Phase I Environmental Site Assessment

Former Mid-America Dairymen, Inc. Plant
301 South Buse Street
Fergus Falls, Minnesota

Project B1606338.01
January 4, 2018

Braun Intertec Corporation

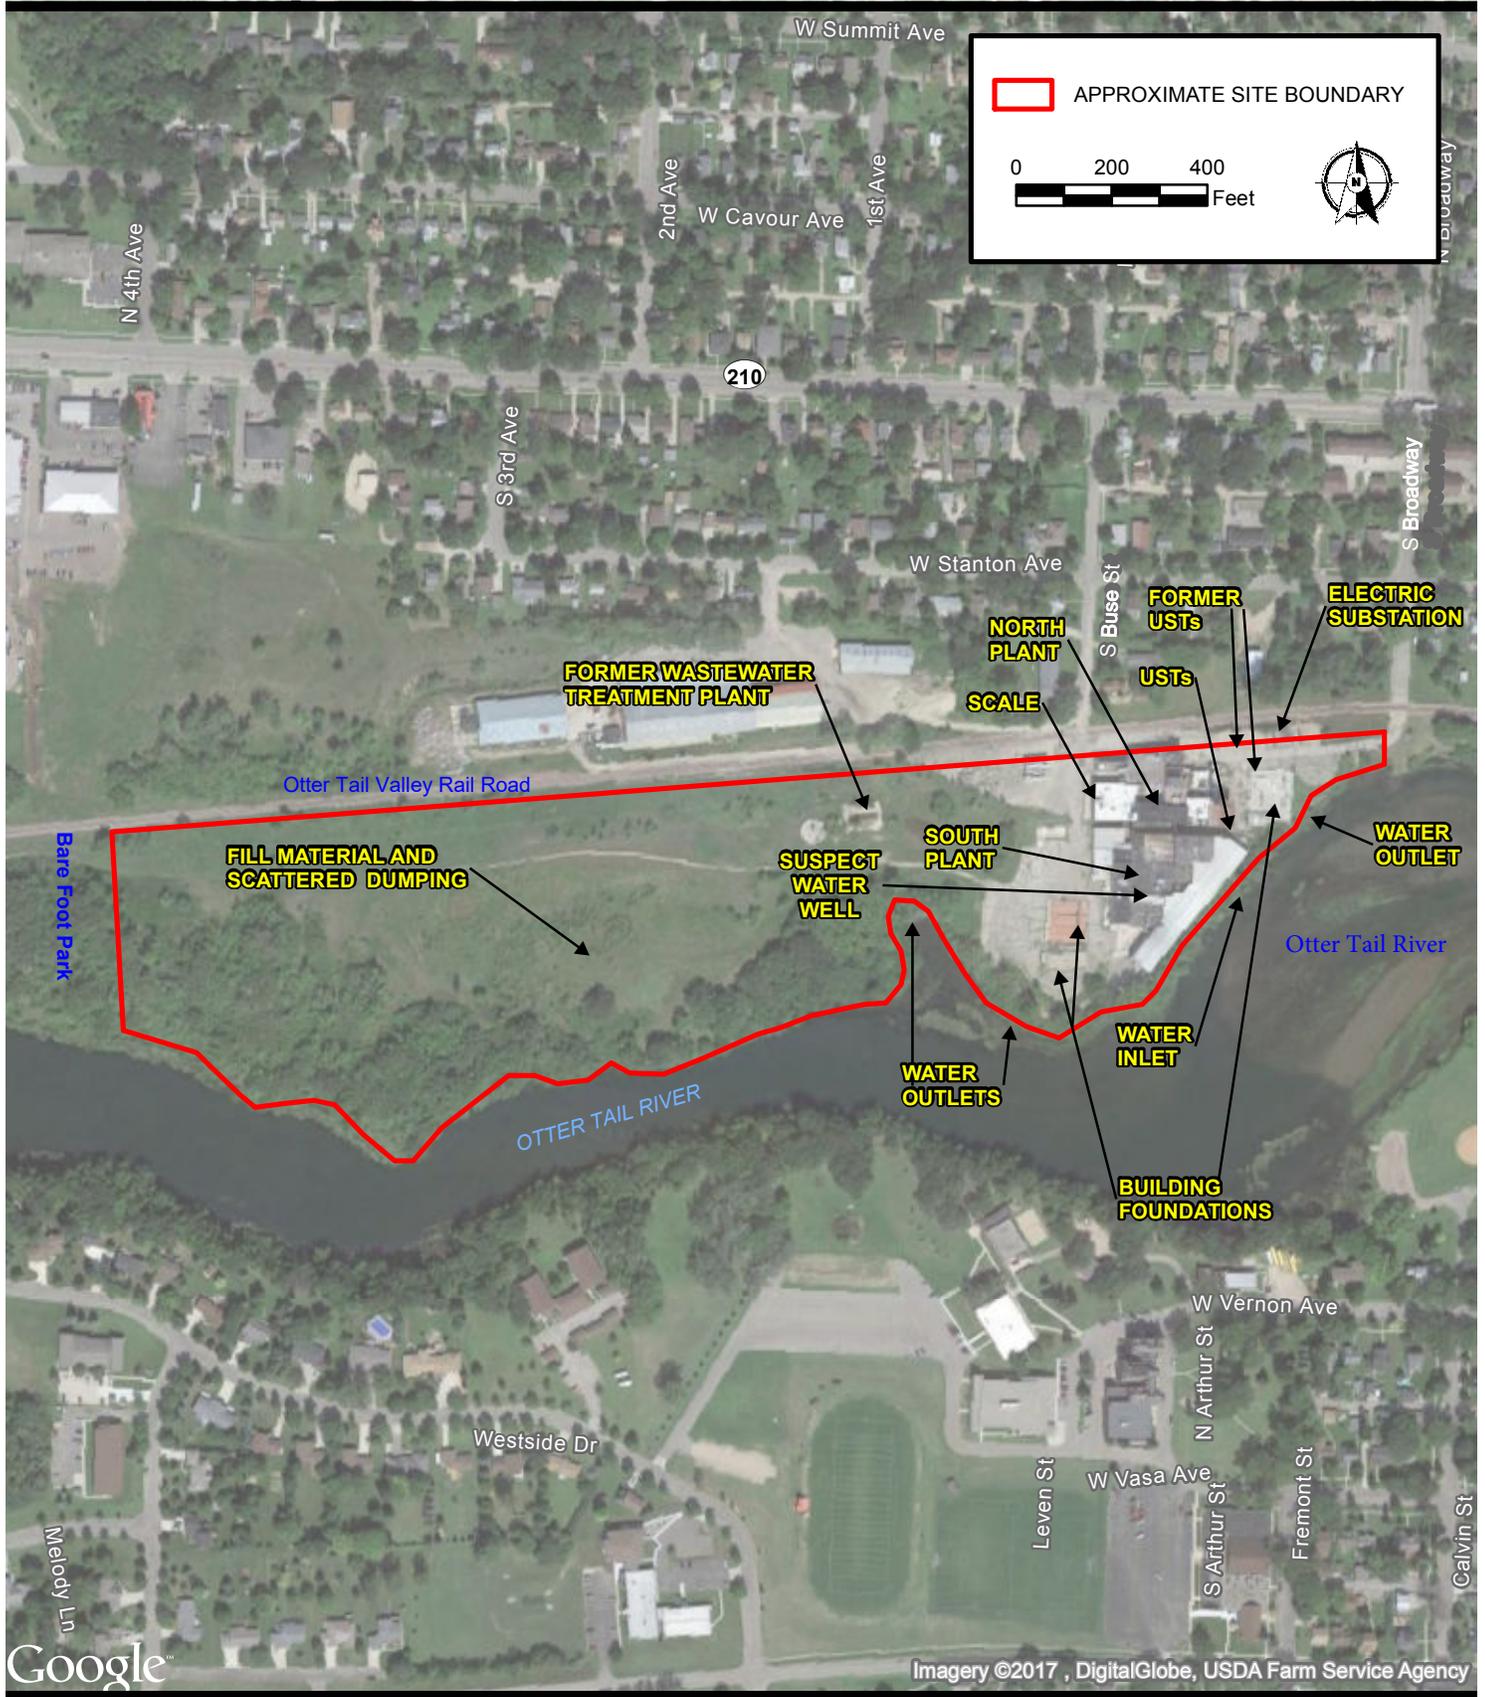
Site Sketch

SITE SKETCH
FORMER MID-AMERICA DAIRYMEN, INC. PLANT
301 SOUTH BUSE STREET
FERGUS FALLS, MINNESOTA

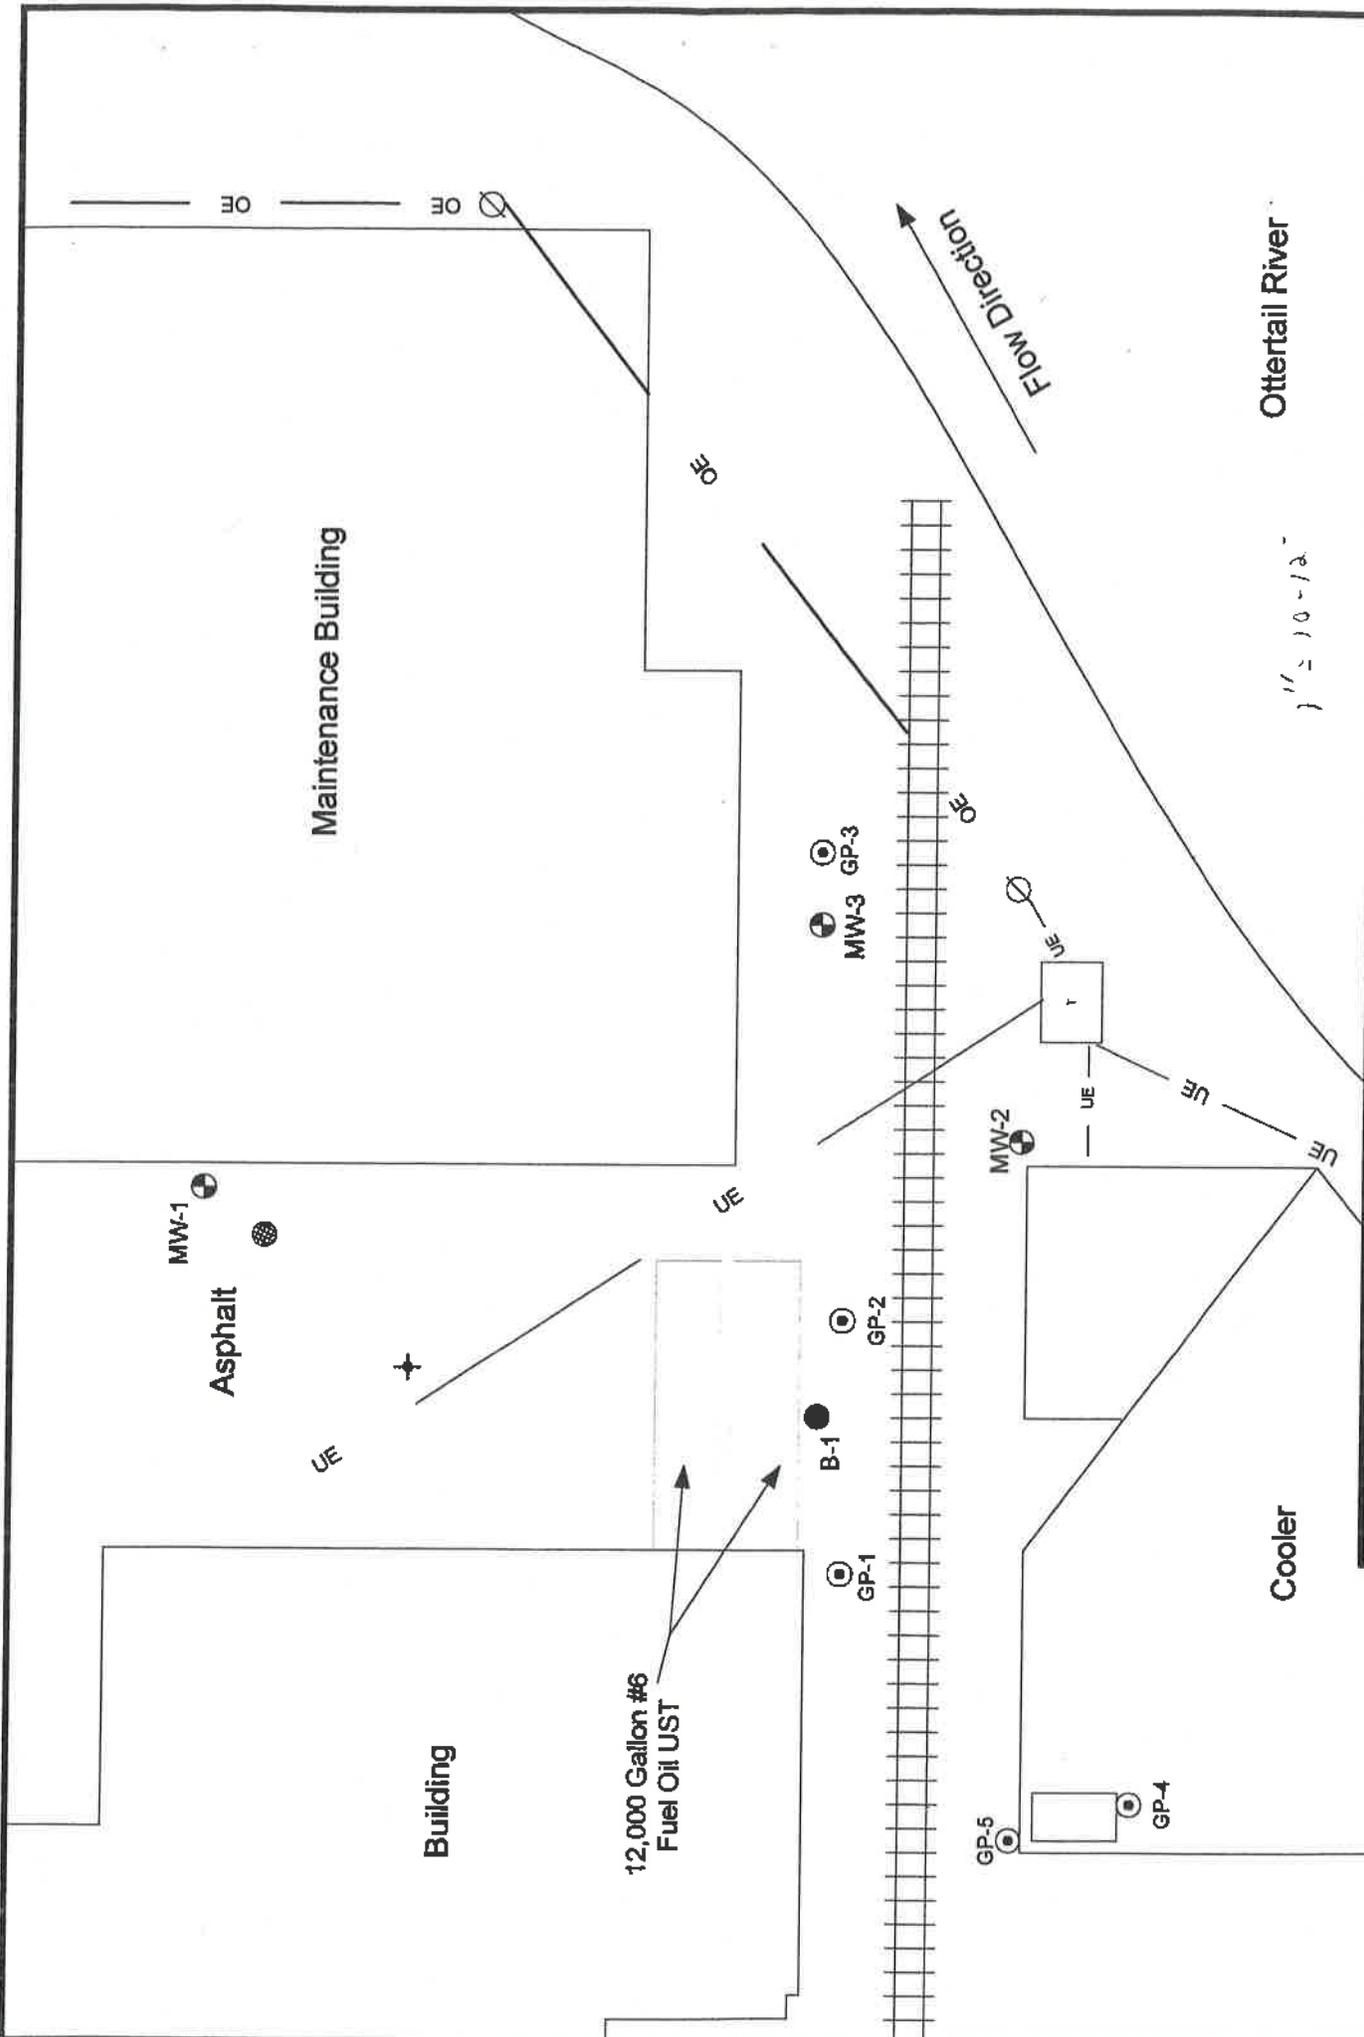
2

Soil Boring Location Map
 Dairy Farmers of America
 301 South Base Street
 Fergus Falls, Minnesota

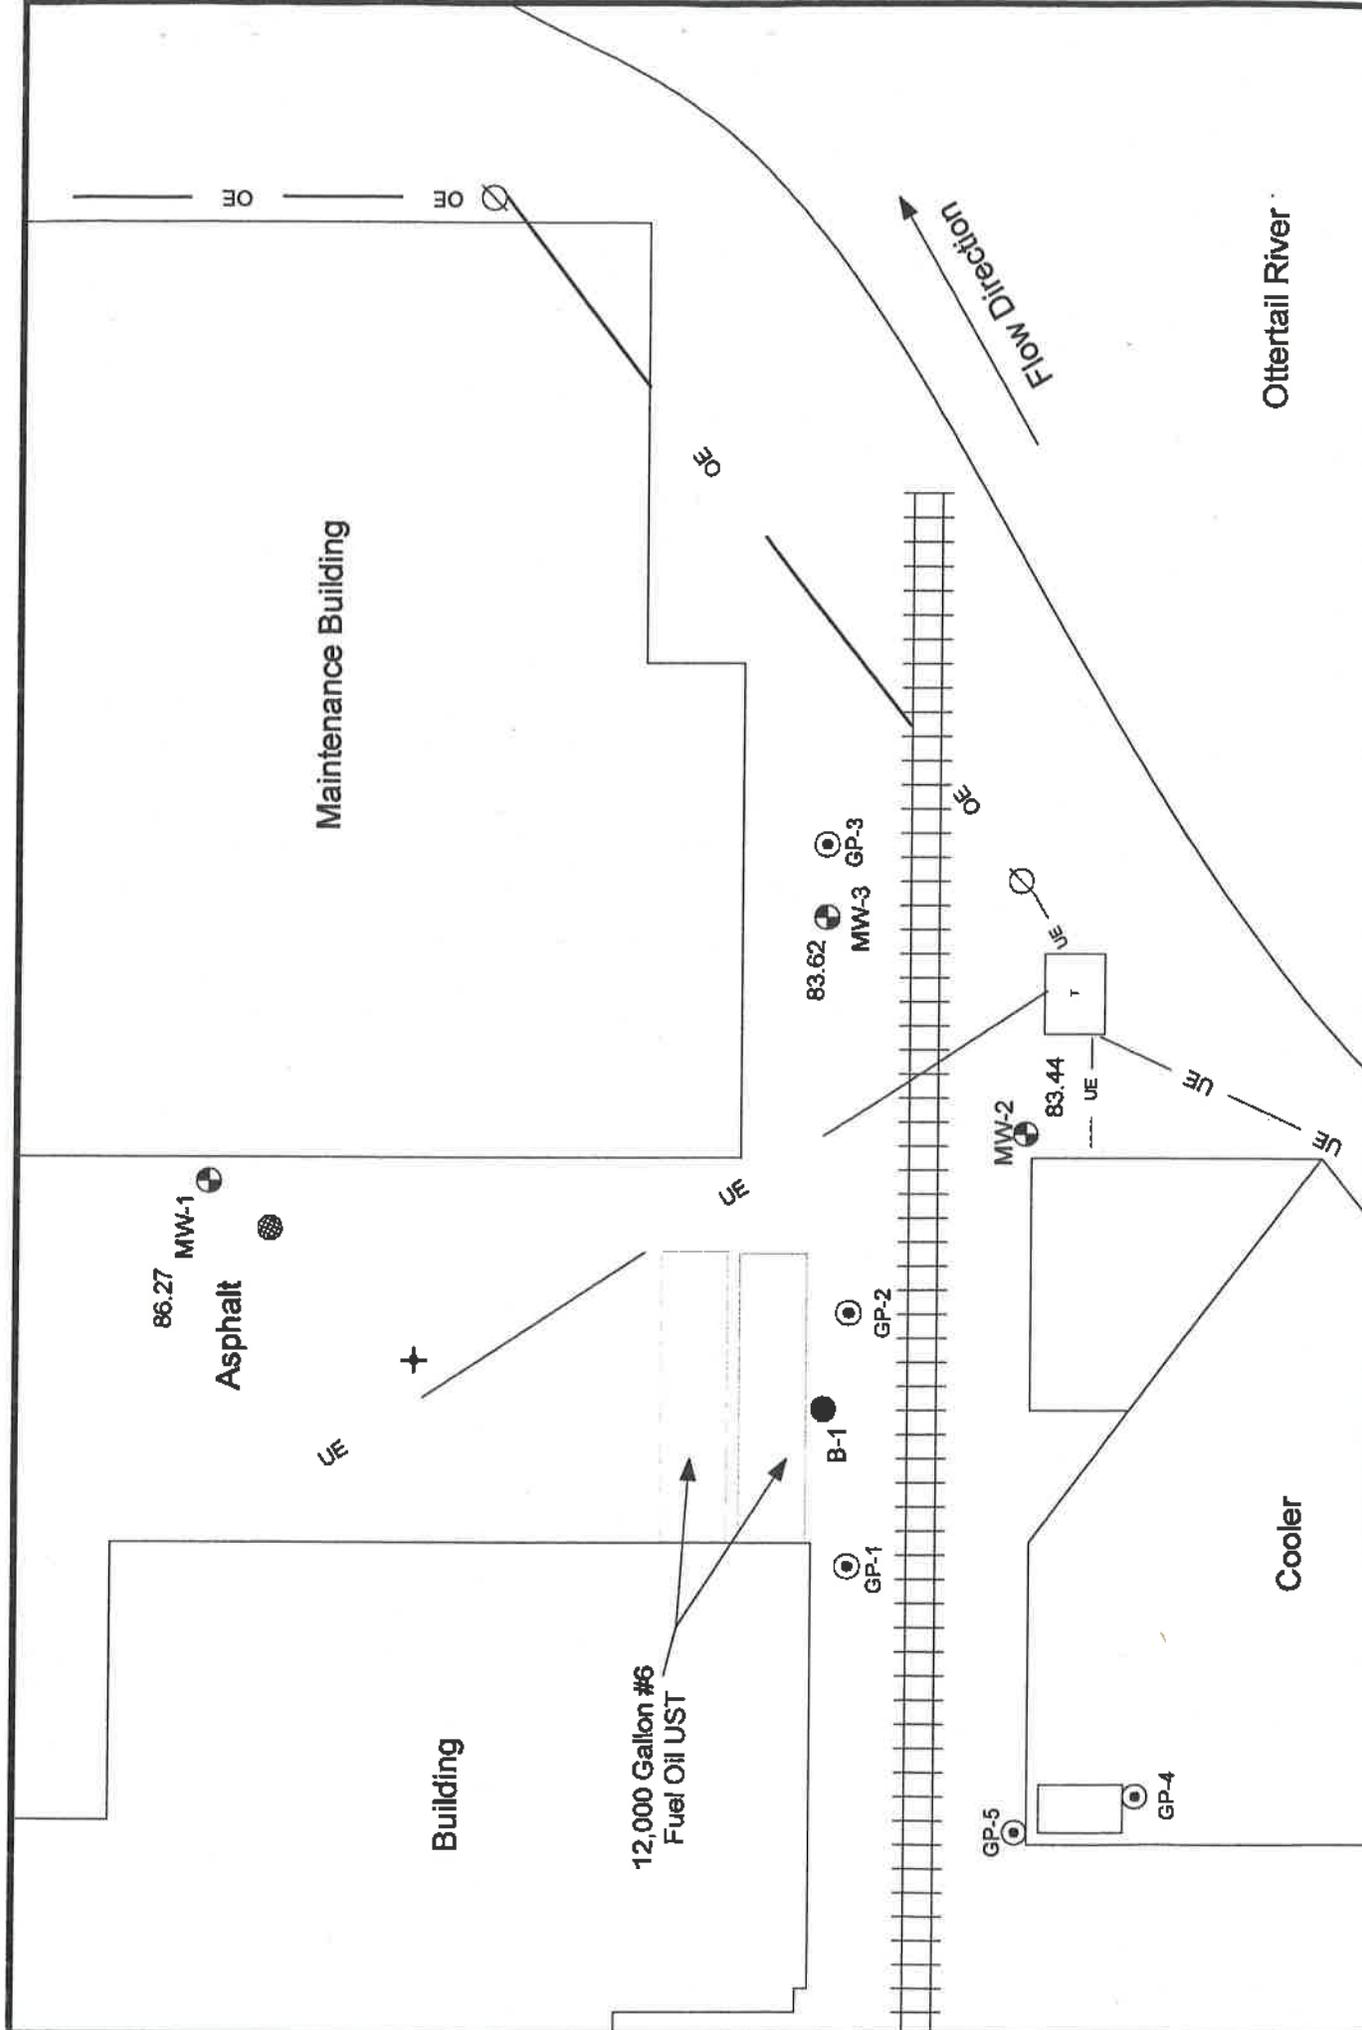
Based on water level measurements taken from MW-1, MW-2 and MW-3 groundwater appears to be flowing to the south toward the Otter Tail River. Groundwater flow direction maps are attached as Figure 3 and Figure 4.

Groundwater Flow Direction - 5/29/02
Dairy Farmers of America
301 South Buse Street
Fergus Falls, Minnesota

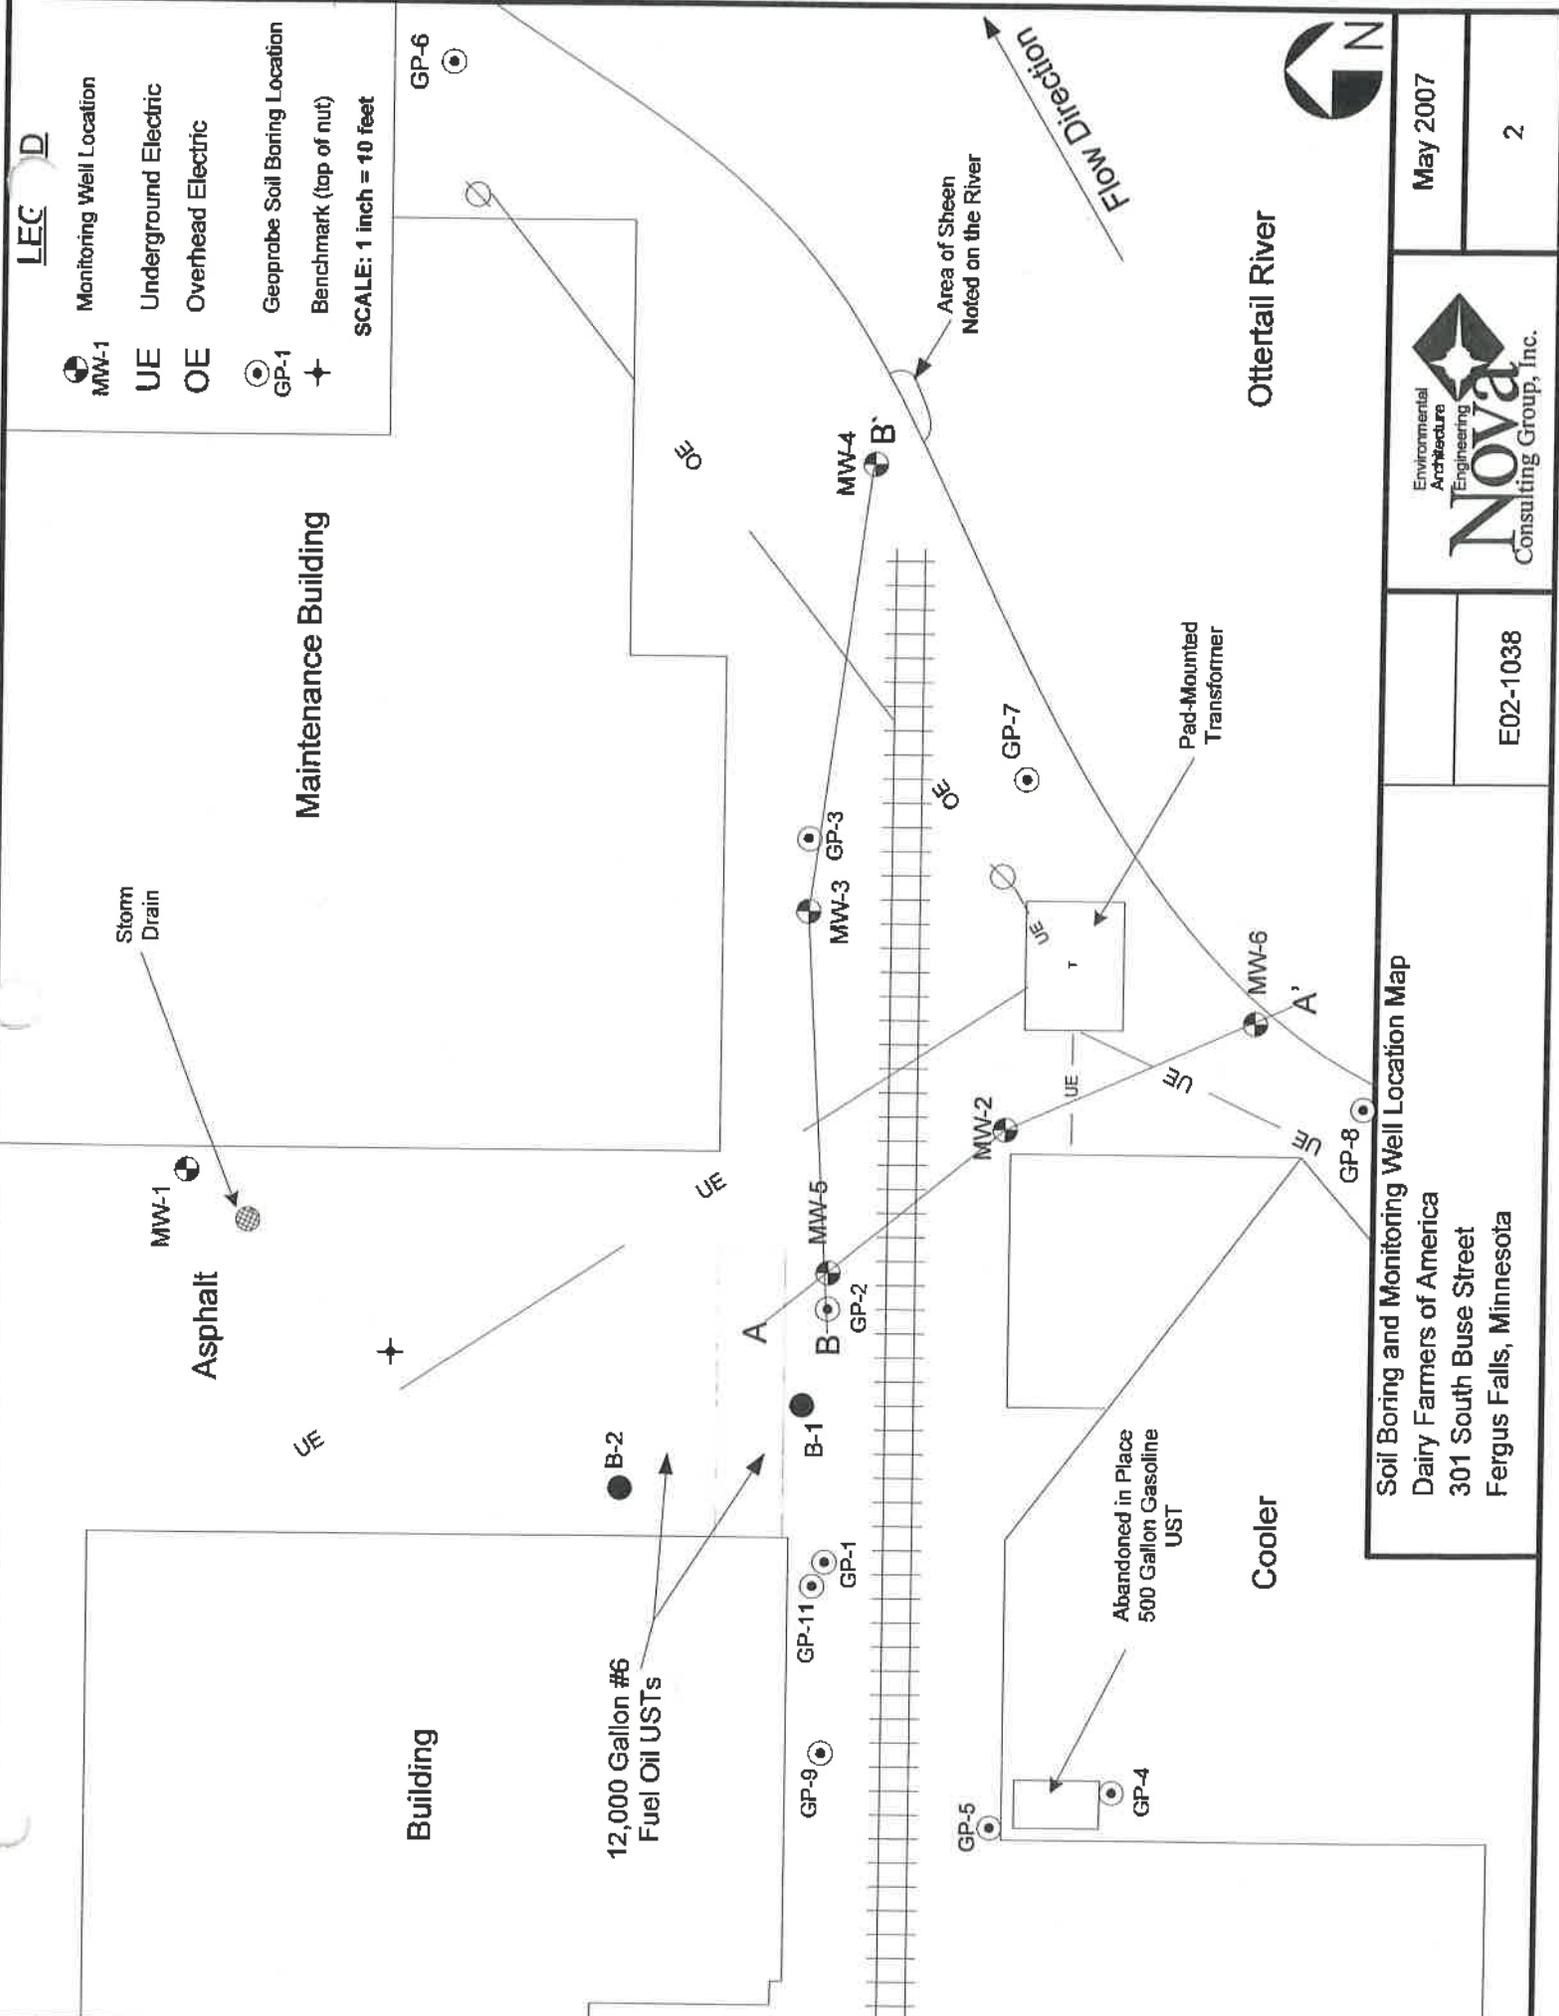
Benchmark is identified as top of nut in asphalt near the manhole to the north of the USTs. The nut was given an elevation of 100.00. The benchmark is depicted on Figure 2.

- MW-1 Monitoring Well Location
 - UE Underground Electric
 - OE Overhead Electric
 - GP-1 Geoprobe Soil Boring Location
 - + Benchmark (top of nut)
- SCALE: 1 inch = 10 feet**

Soil Boring and Monitoring Well Location Map
Dairy Farmers of America
301 South Buse Street
Fergus Falls, Minnesota

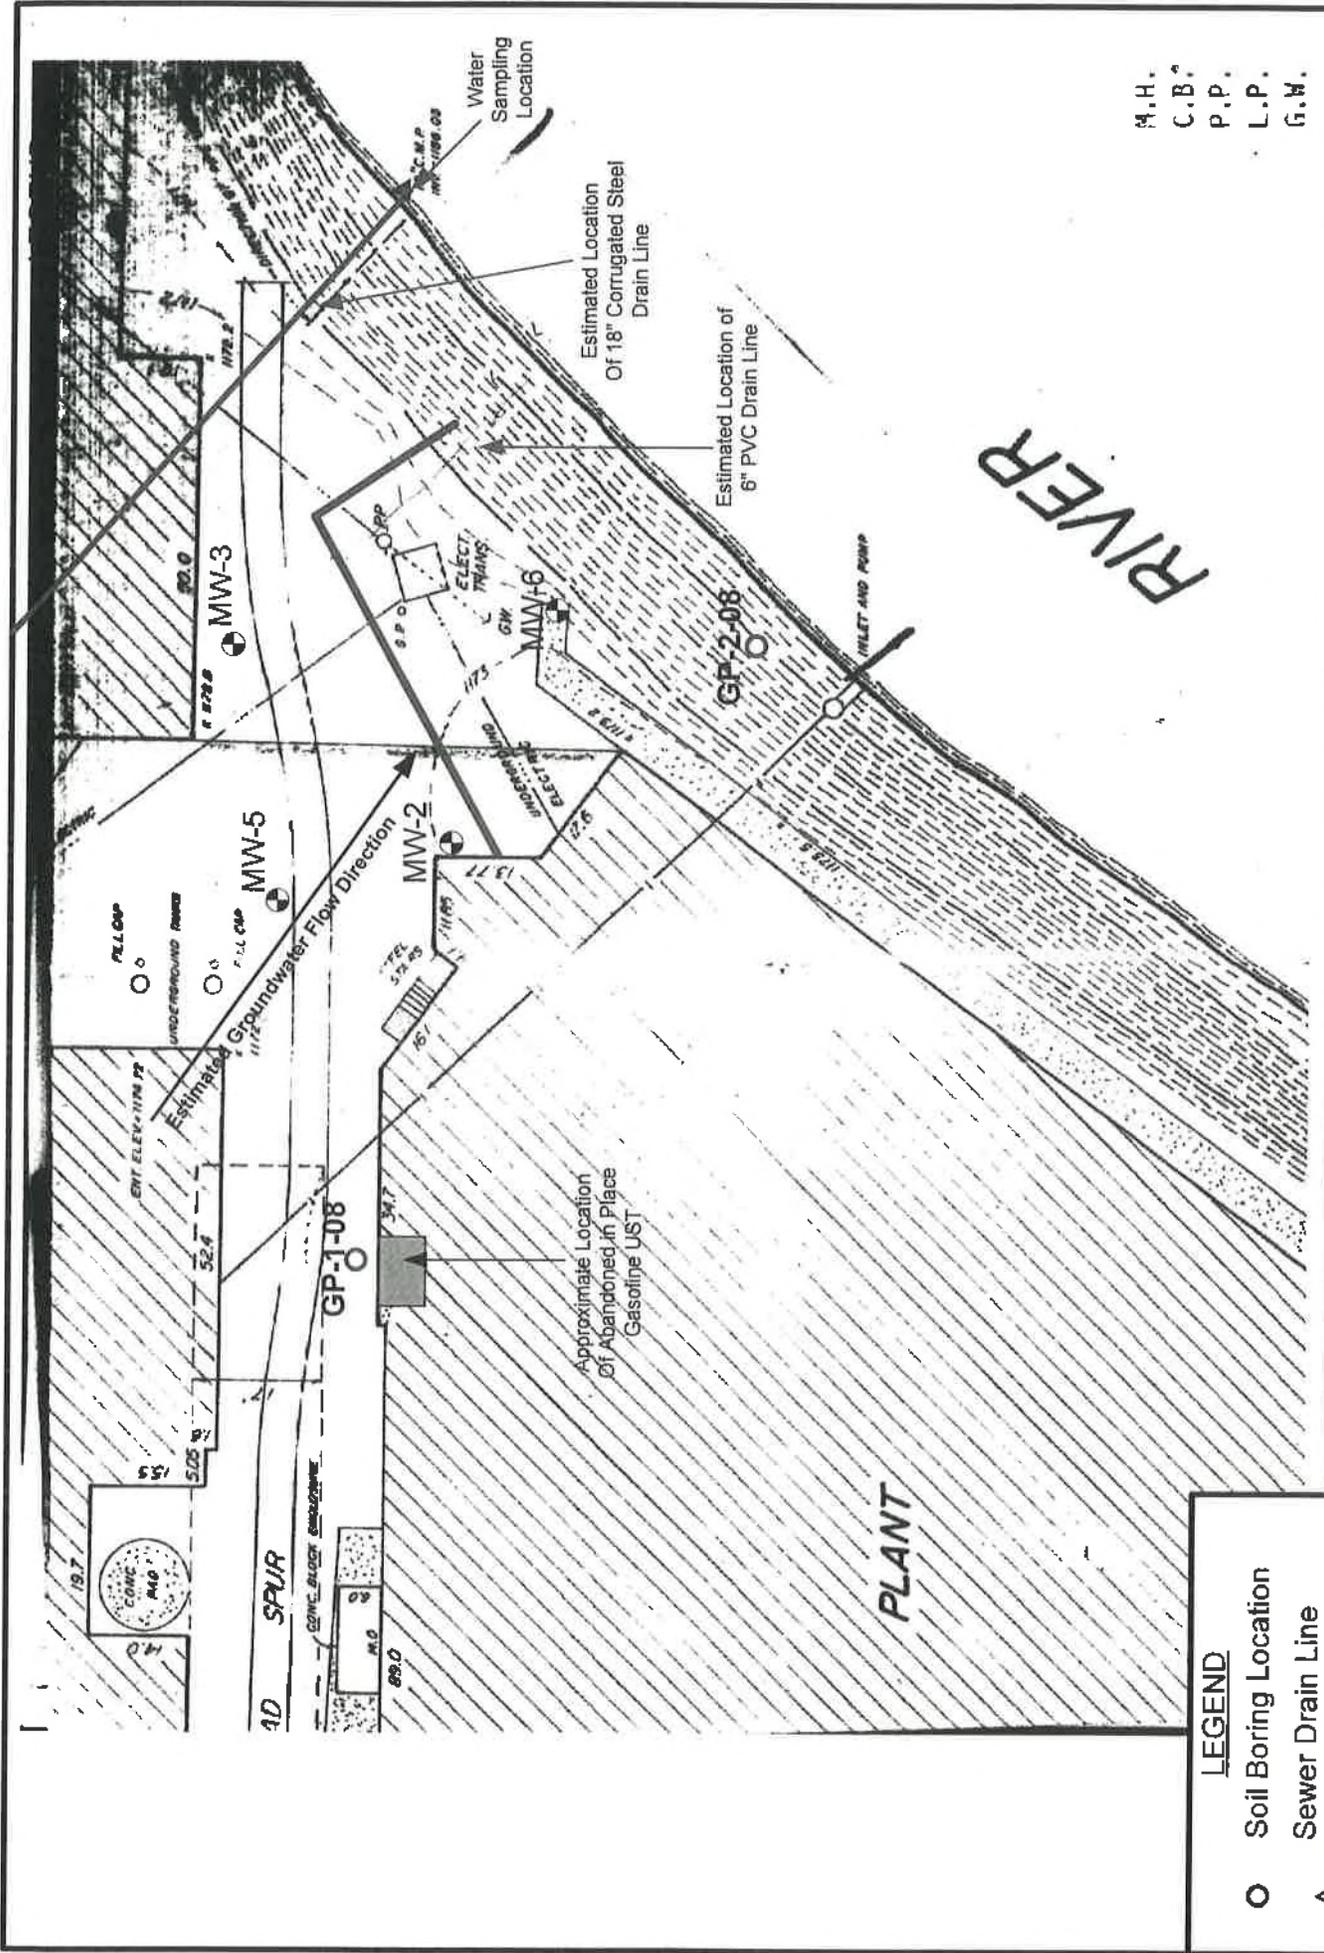
January 2009
Figure 2

On November 20, 2008, Nova advanced two soil borings (GP-1-08 and GP-2-08) to assess the potential of petroleum impacts to the surface soils and groundwater at the Site associated with the previously "abandoned-in-place" gasoline underground storage tank located within the chiller building. GP-1-08 was completed to 23 feet bg and was advanced adjacent to the abandoned gasoline UST. GP-2-08 was completed to 5 feet bg and was advanced near the Otter Tail River at a down gradient location from the abandoned gasoline UST. A Soil Boring Location Map is included as Figure 2.

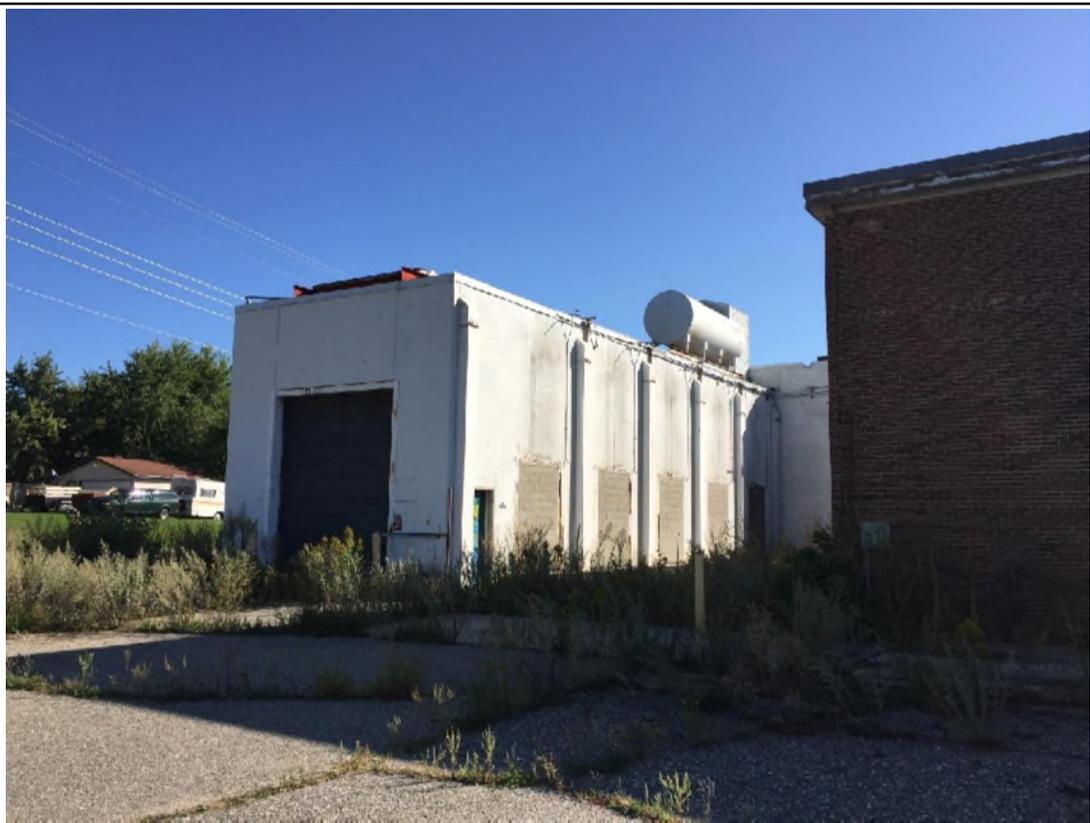
Photograph #1	Vacated Cheese Processing Plant, Fergus Falls, MN	B1606338.01
Date:	September 20, 2017

Direction:	Northeast	
Subject:	Northwest corner of north plant building

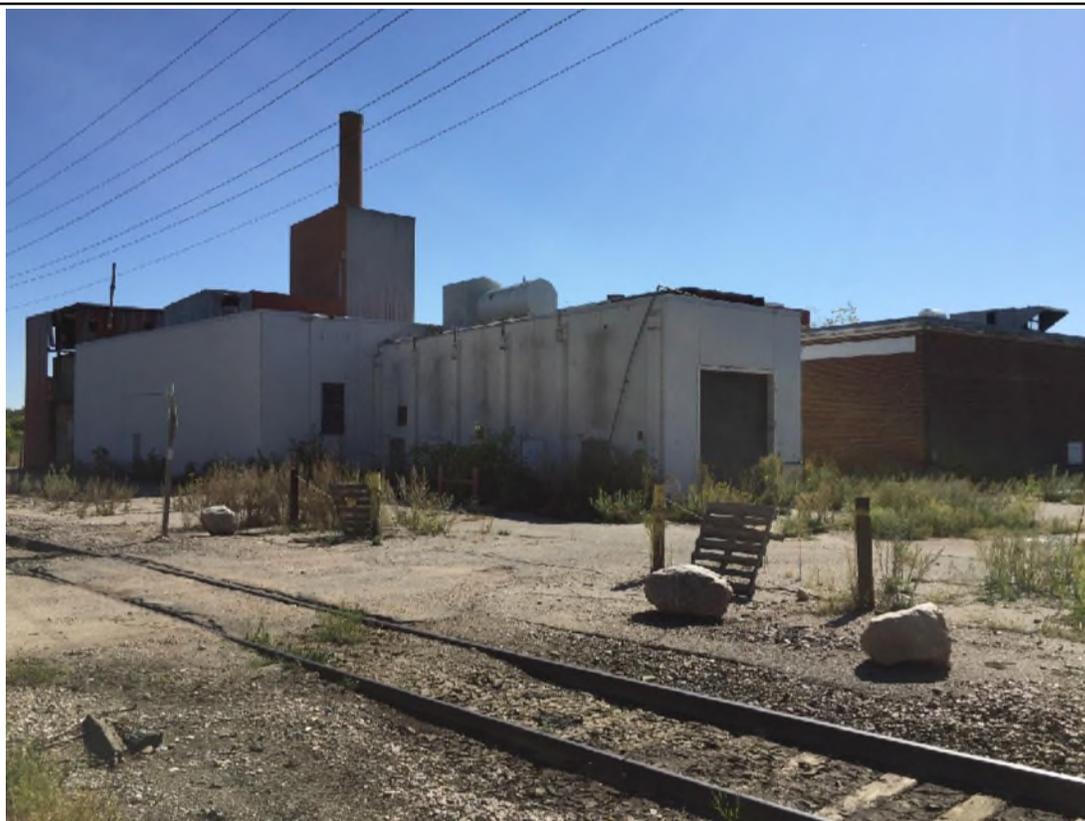
Photograph #3	Vacated Cheese Processing Plant, Fergus Falls, MN	B1606338.01
Date:	September 20, 2017

Direction:	Southeast	
Subject:	West side of Site buildings

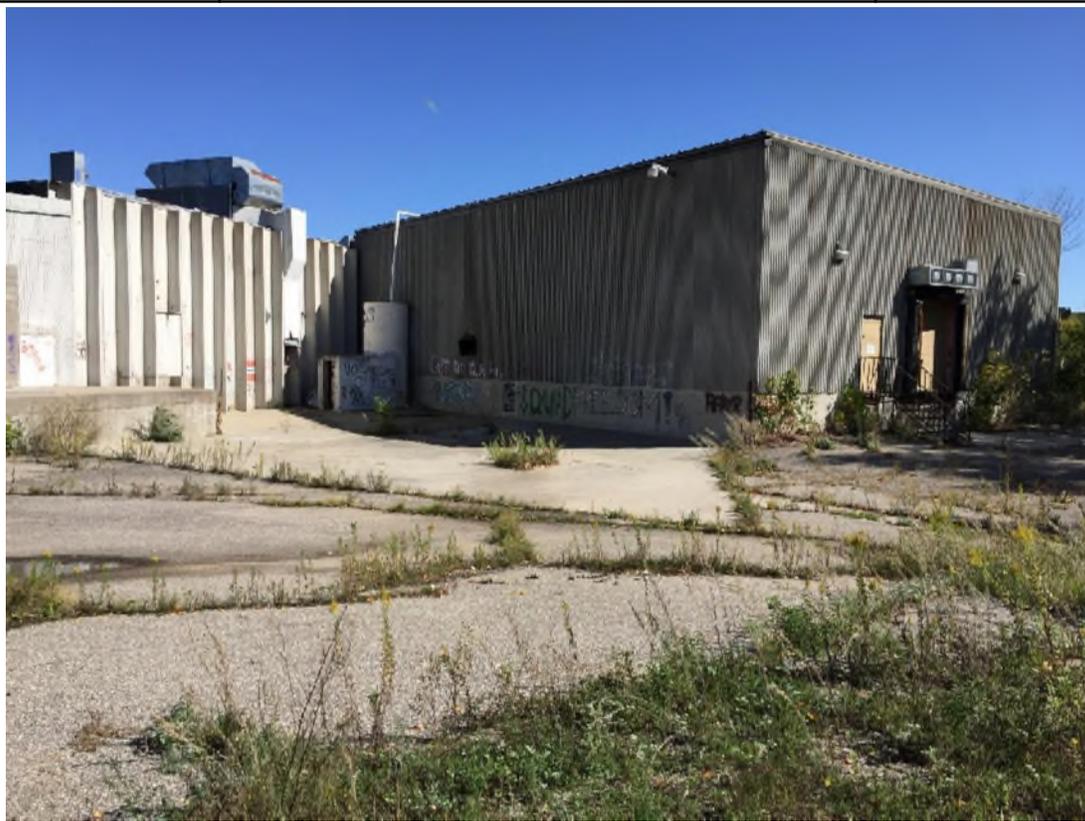
Photograph #4	Vacated Cheese Processing Plant, Fergus Falls, MN	B1606338.01
Date:	September 20, 2017

Direction:	Southeast	
Subject:	North plant building

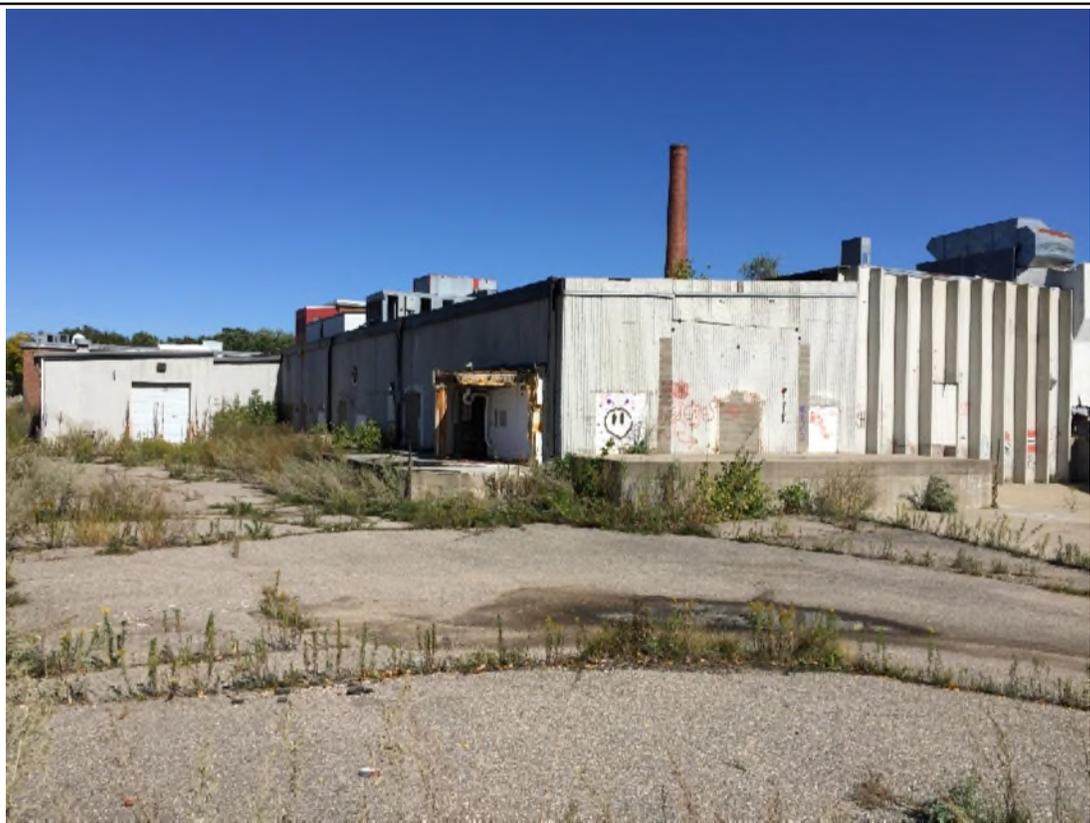
Photograph #5	Vacated Cheese Processing Plant, Fergus Falls, MN	B1606338.01
Date:	September 20, 2017

Direction:	Northeast	
Subject:	South end of south plant building

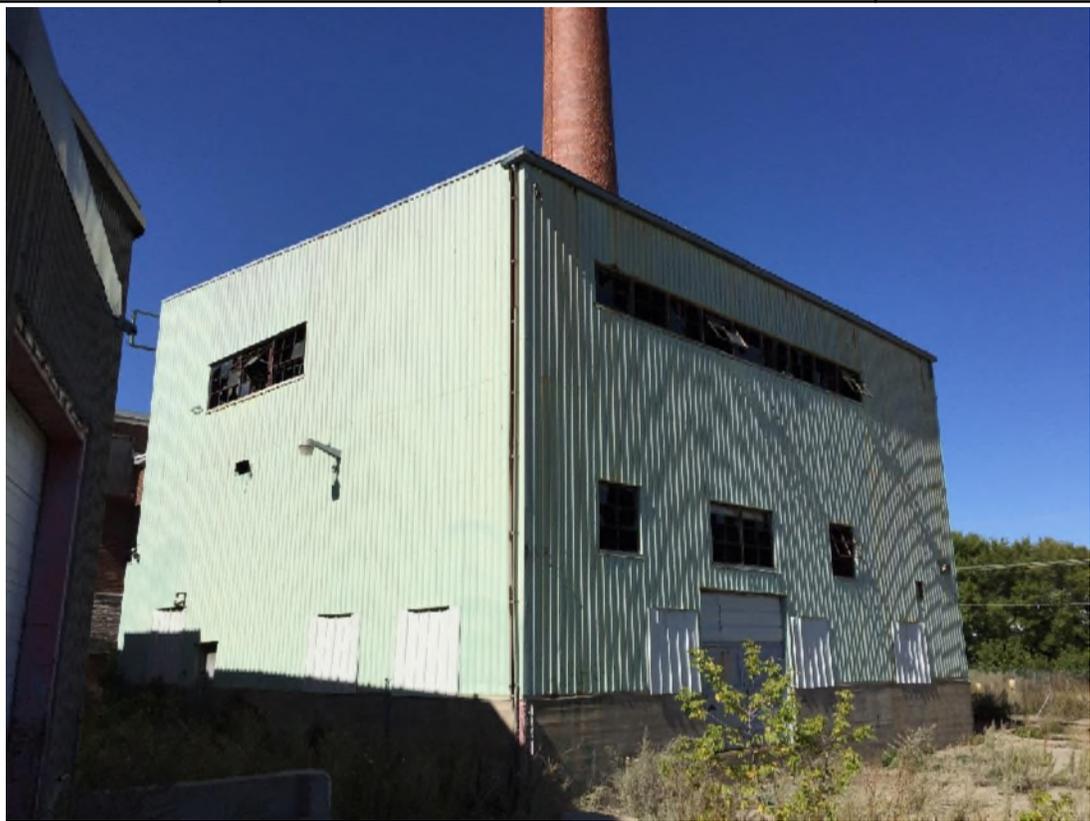
Photograph #6	Vacated Cheese Processing Plant, Fergus Falls, MN	B1606338.01
Date:	September 20, 2017

Direction:	Northwest	
Subject:	Boiler room portion of north plant building

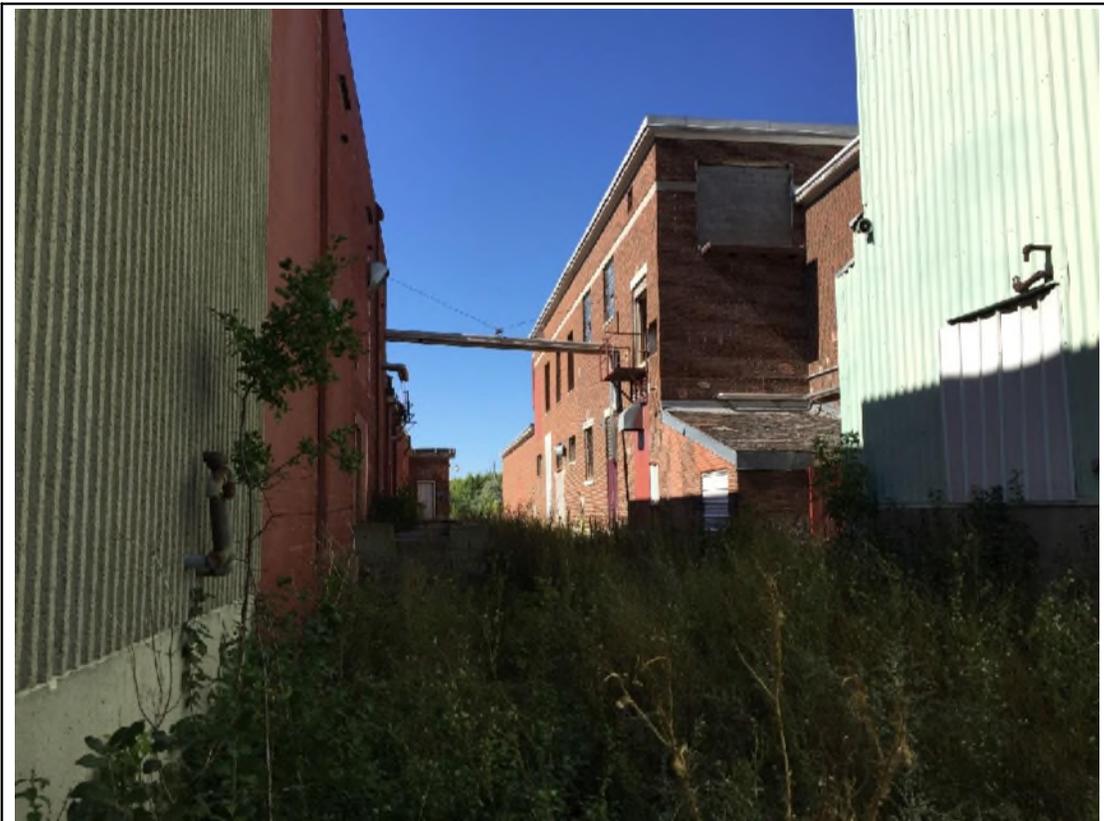
Photograph #7	Vacated Cheese Processing Plant, Fergus Falls, MN	B1606338.01
Date:	September 20, 2017

Damaged friable asbestos and an elemental mercury release is located within the boiler room of the north plant building.

The damaged friable asbestos and elemental mercury release located within the boiler room in the north plant building represents a possible material risk to human health and environment. Braun Intertec recommends this matter be cleaned-up/addressed to proper regulatory agency satisfaction without delay.

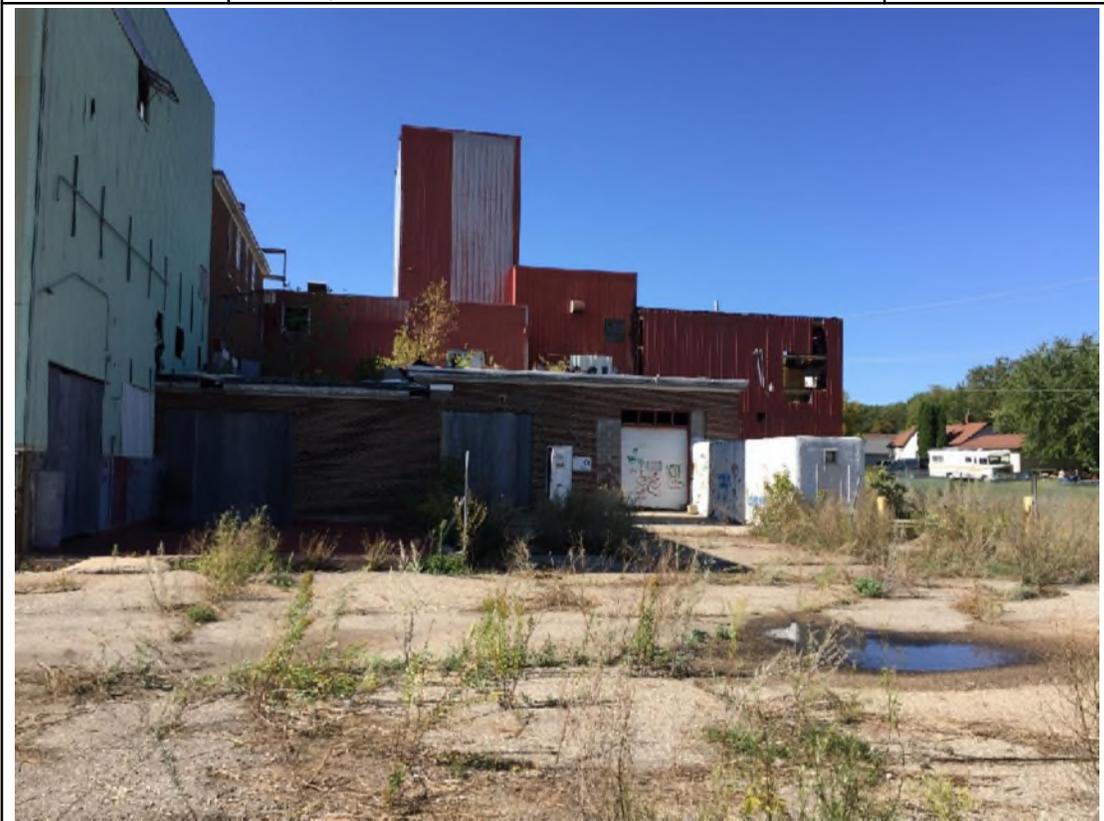
Photograph #8	Vacated Cheese Processing Plant, Fergus Falls, MN	B1606338.01
Date:	September 20, 2017

Direction:	West	
Subject:	Vacated railroad line between north and south buildings

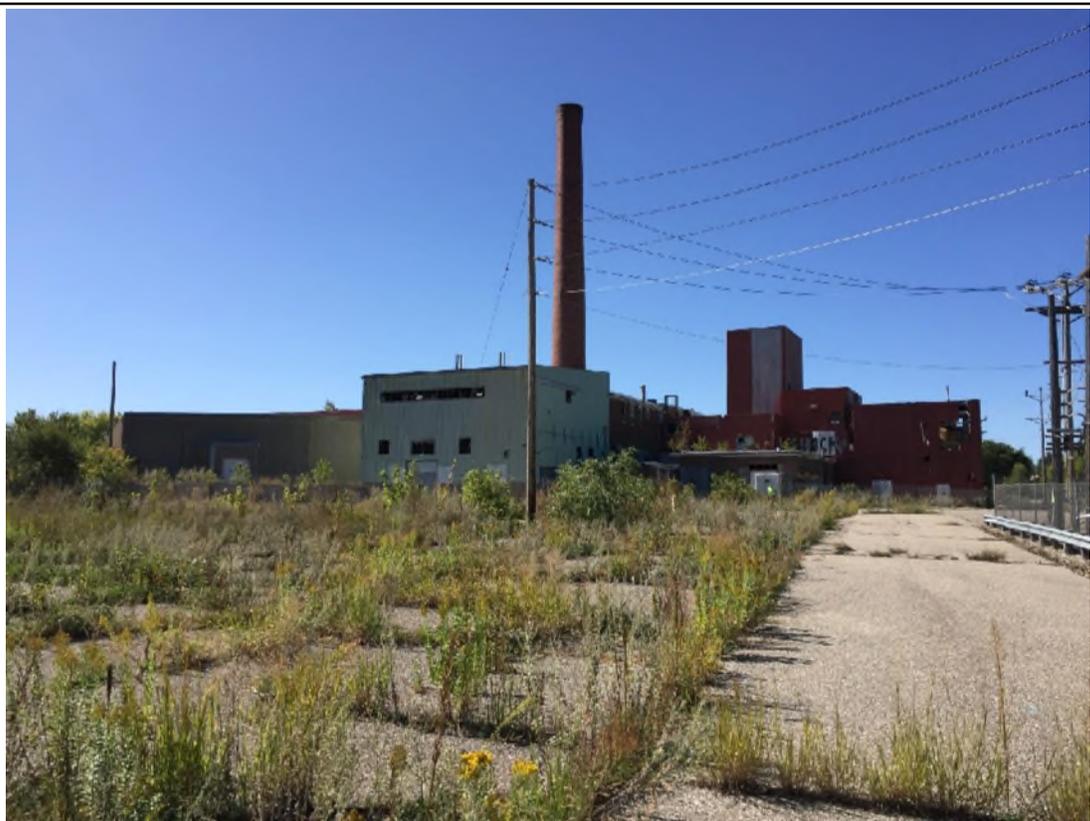
Photograph #9	Vacated Cheese Processing Plant, Fergus Falls, MN	B1606338.01
Date:	September 20, 2017

Direction:	West	
Subject:	Northern portion of north plant building

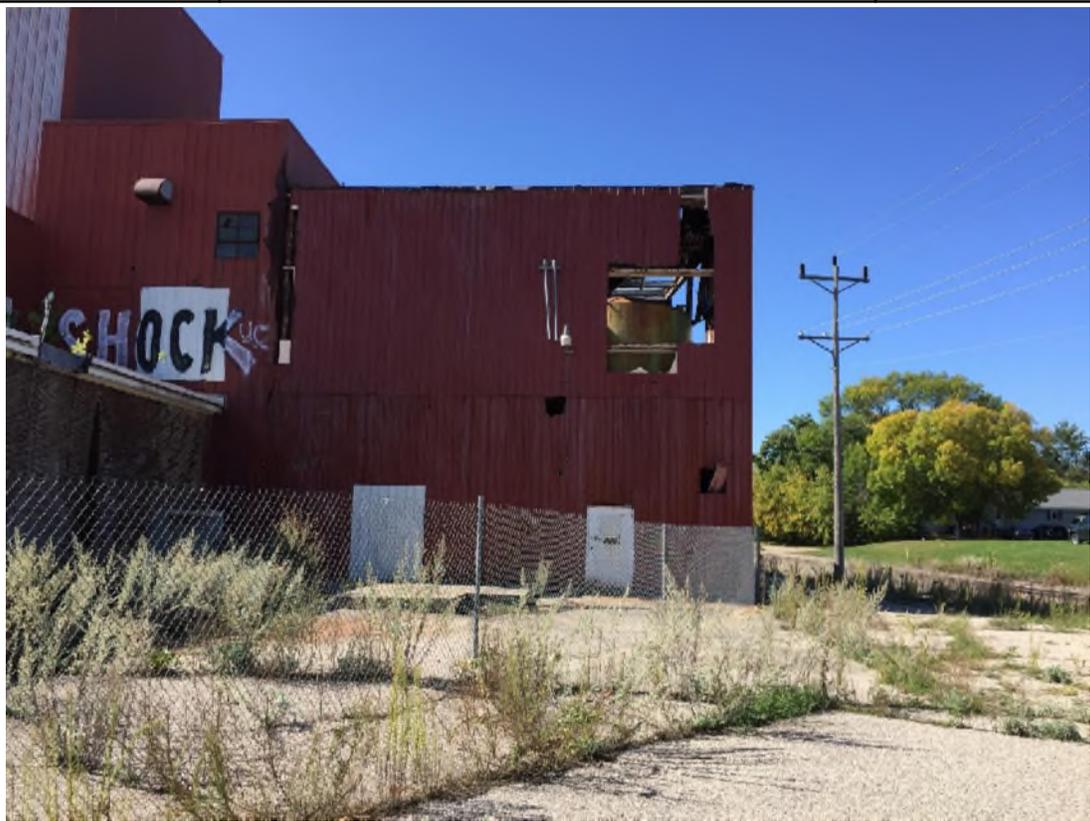
Photograph #10	Vacated Cheese Processing Plant, Fergus Falls, MN	B1606338.01
Date:	September 20, 2017

Direction:	West	
Subject:	ASTs on mezzanine in north plant building
