Phase I Environmental Site Assessment

Former Mid-America Dairymen, Inc. Plant
301 South Buse Street
Fergus Falls, Minnesota

Project B1606338.01
January 4, 2018

Braun Intertec Corporation

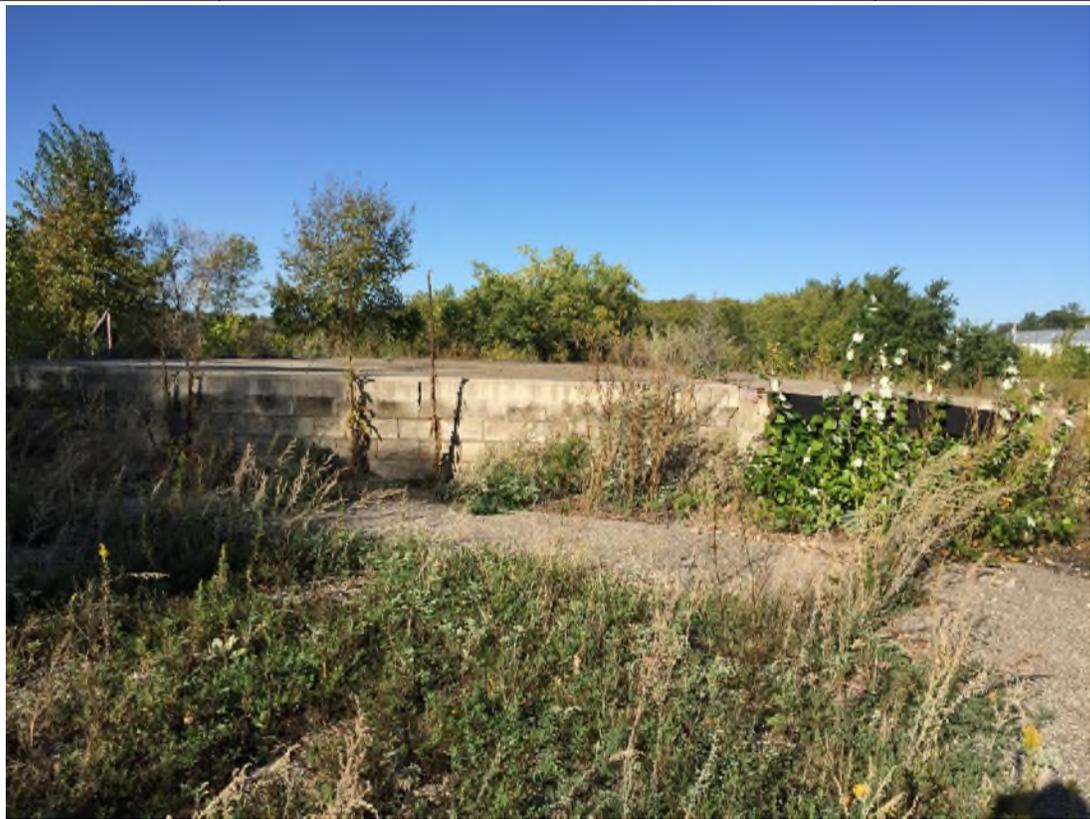
Photograph #12	Vacated Cheese Processing Plant, Fergus Falls, MN	B1606338.01
Date:	September 20, 2017	
Direction:	West	
Subject:	Foundation to west of south plant building

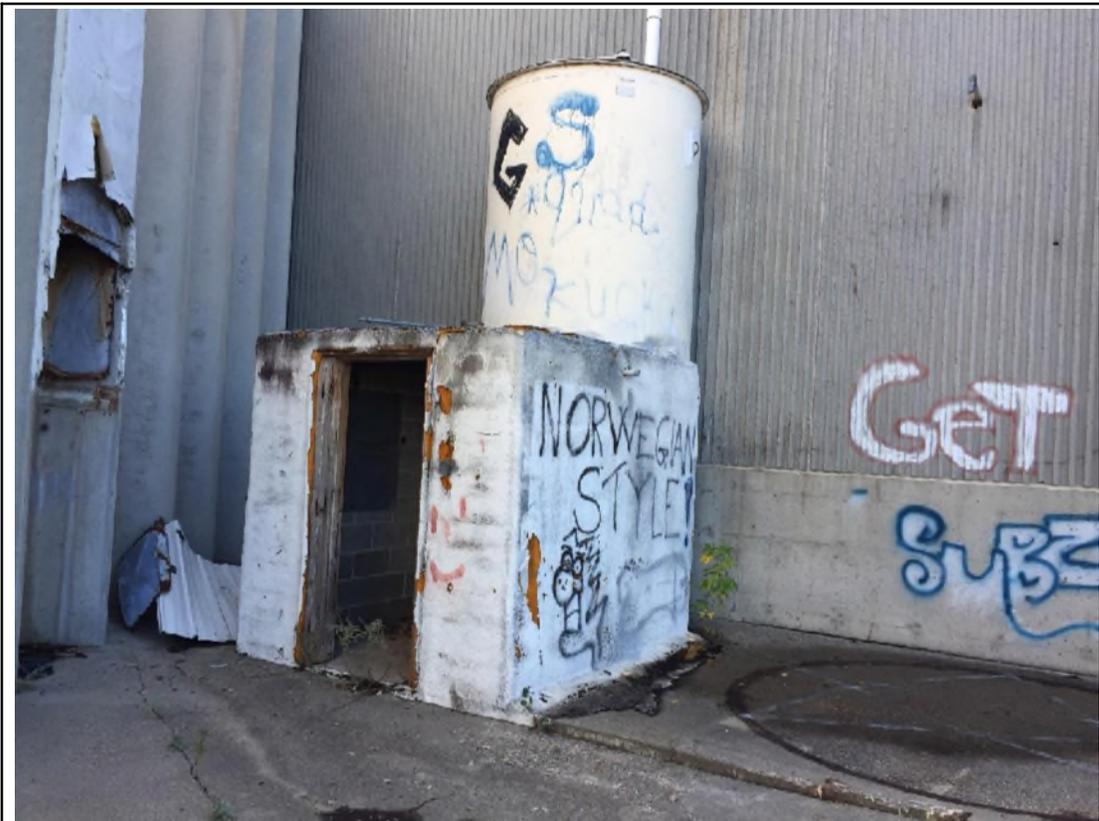
Photograph #13	Vacated Cheese Processing Plant, Fergus Falls, MN	B1606338.01
Date:	September 20, 2017

Direction:	East	
Subject:	AST on west side of south plant building and typical AST staining

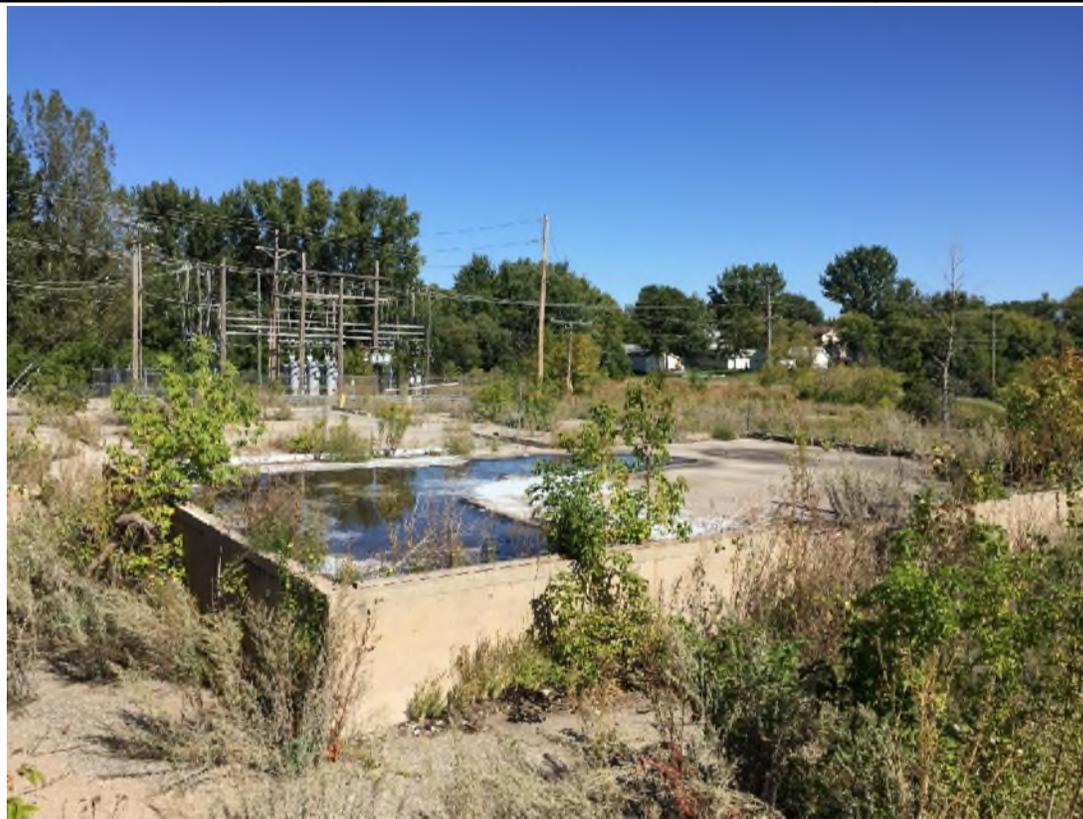
Photograph #14	Vacated Cheese Processing Plant, Fergus Falls, MN	B1606338.01
Date:	September 20, 2017

Direction:	Northeast	
Subject:	Foundation east of north plant building

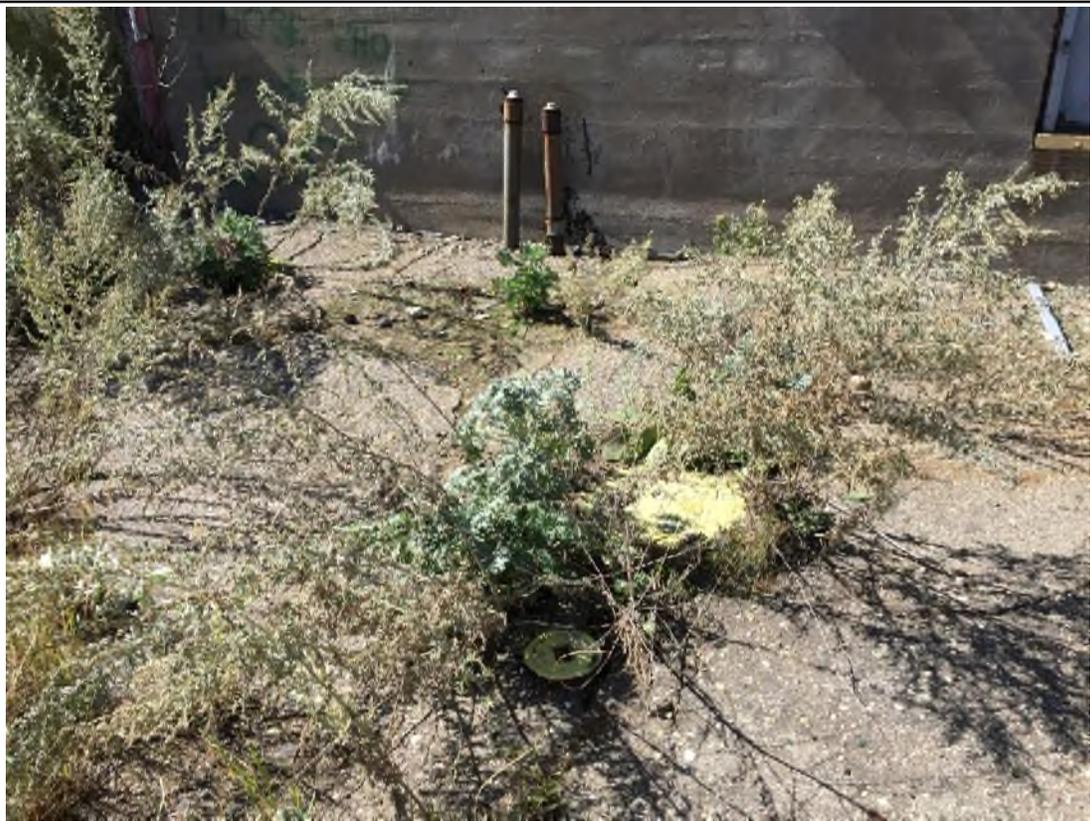
Photograph #15	Vacated Cheese Processing Plant, Fergus Falls, MN	B1606338.01
Date:	September 20, 2017	
Direction:	West	
Subject:	UST fill ports on east side of north plant building

Based on the available information, a 610-foot water well reportedly exists within the south plant building. If a well is encountered during future Site development activities, we recommend that the well be properly abandoned in accordance with Minnesota Department of Health regulations. Also, the three closed in-place USTs should be properly removed by a licensed tank removal contractor.

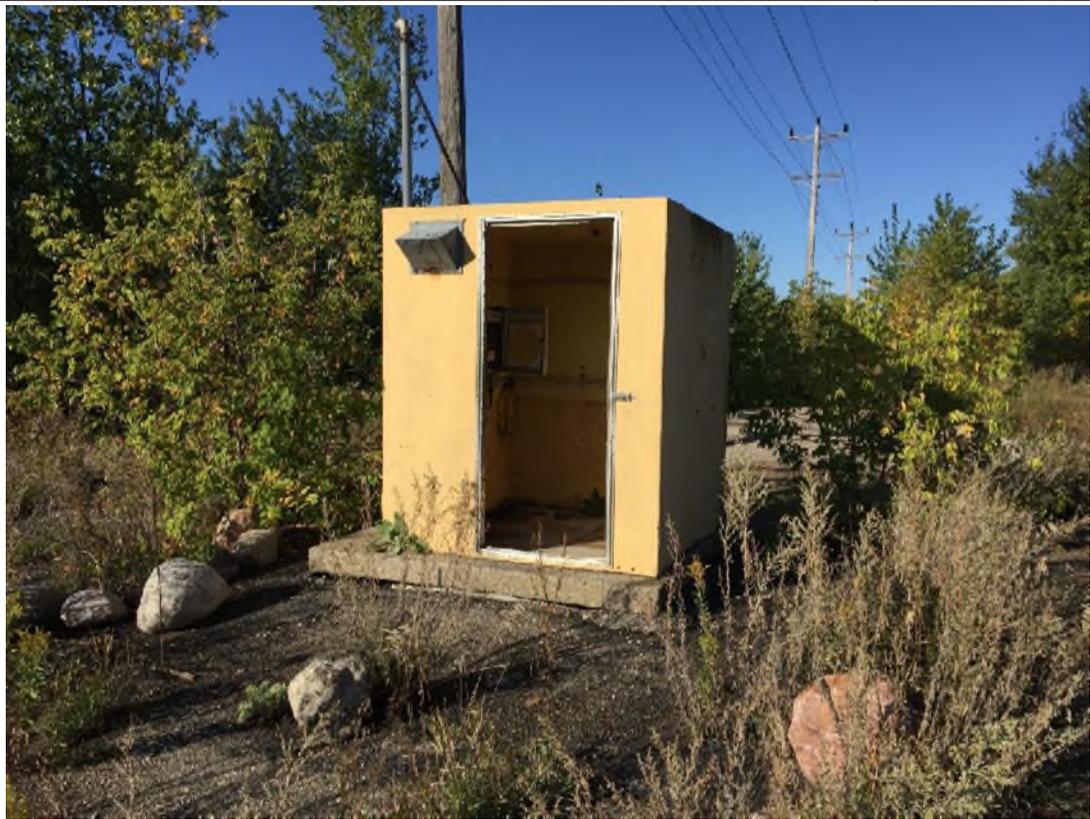
Photograph #16	Vacated Cheese Processing Plant, Fergus Falls, MN	B1606338.01
Date:	September 20, 2017	
Direction:	West	
Subject:	Building at west end of parking lot

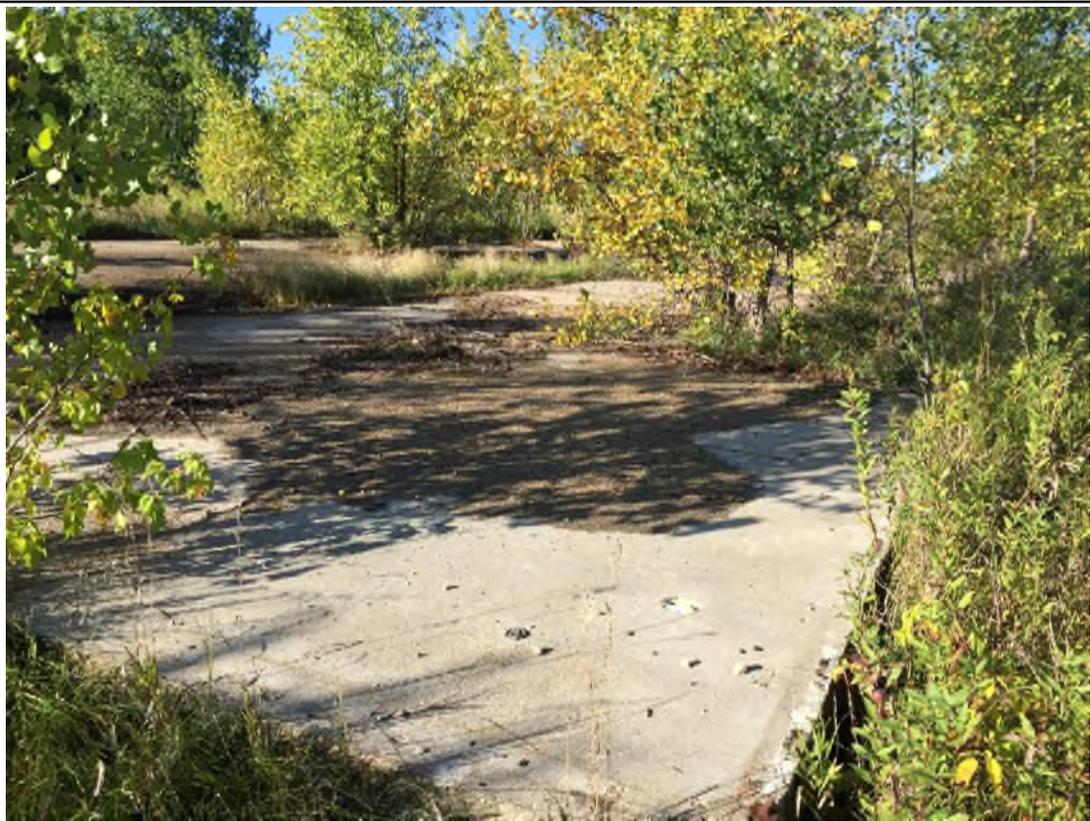
Photograph #17	Vacated Cheese Processing Plant, Fergus Falls, MN	B1606338.01
Date:	September 20, 2017	
Direction:	West	
Subject:	Foundation of former wastewater treatment plant

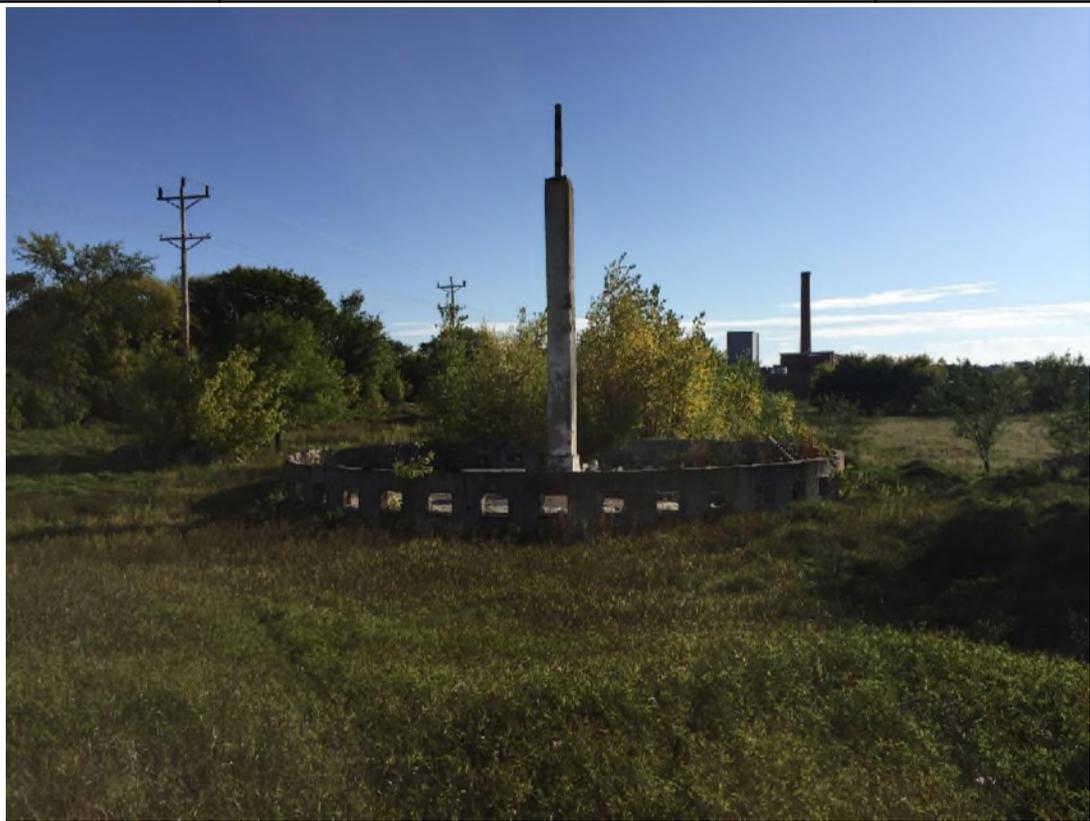
Photograph #18	Vacated Cheese Processing Plant, Fergus Falls, MN	B1606338.01
Date:	September 20, 2017	
Direction:	East	
Subject:	Wastewater treatment aerator

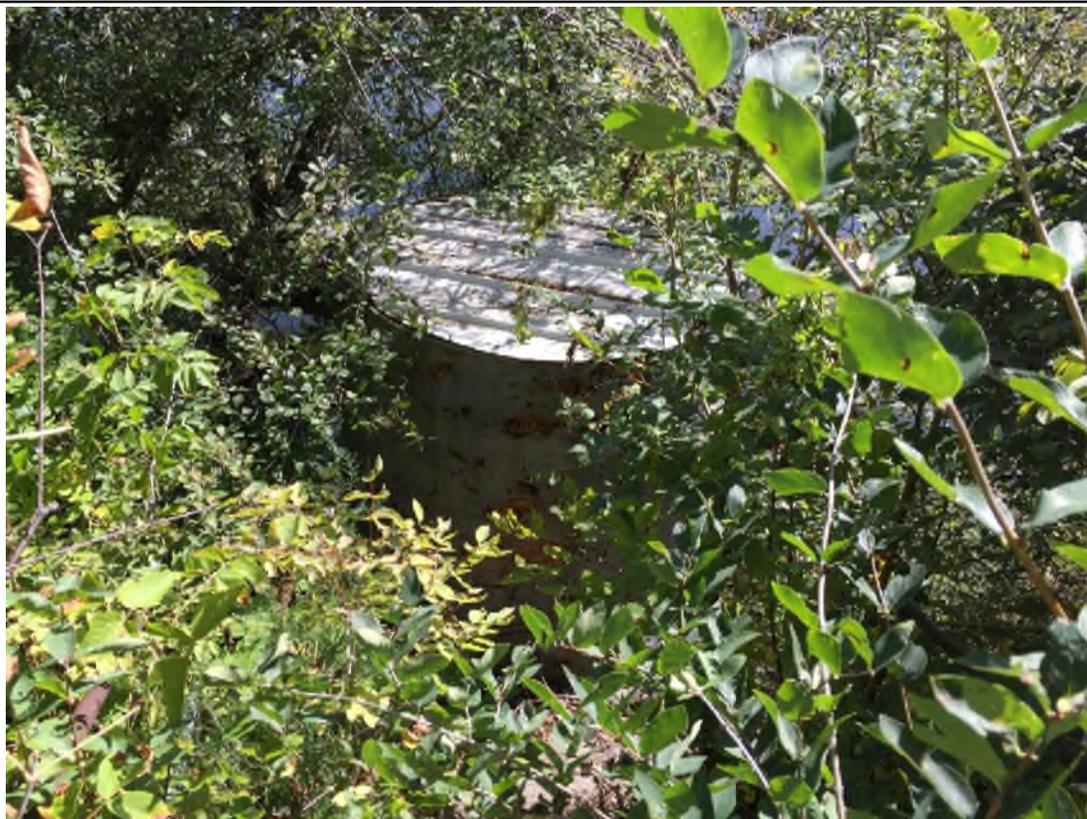
Photograph #19	Vacated Cheese Processing Plant, Fergus Falls, MN	B1606338.01
Date:	September 20, 2017	BRAUN INTERTEC
Direction:	East	
Subject:	Water inlet on river bank to east of south plant

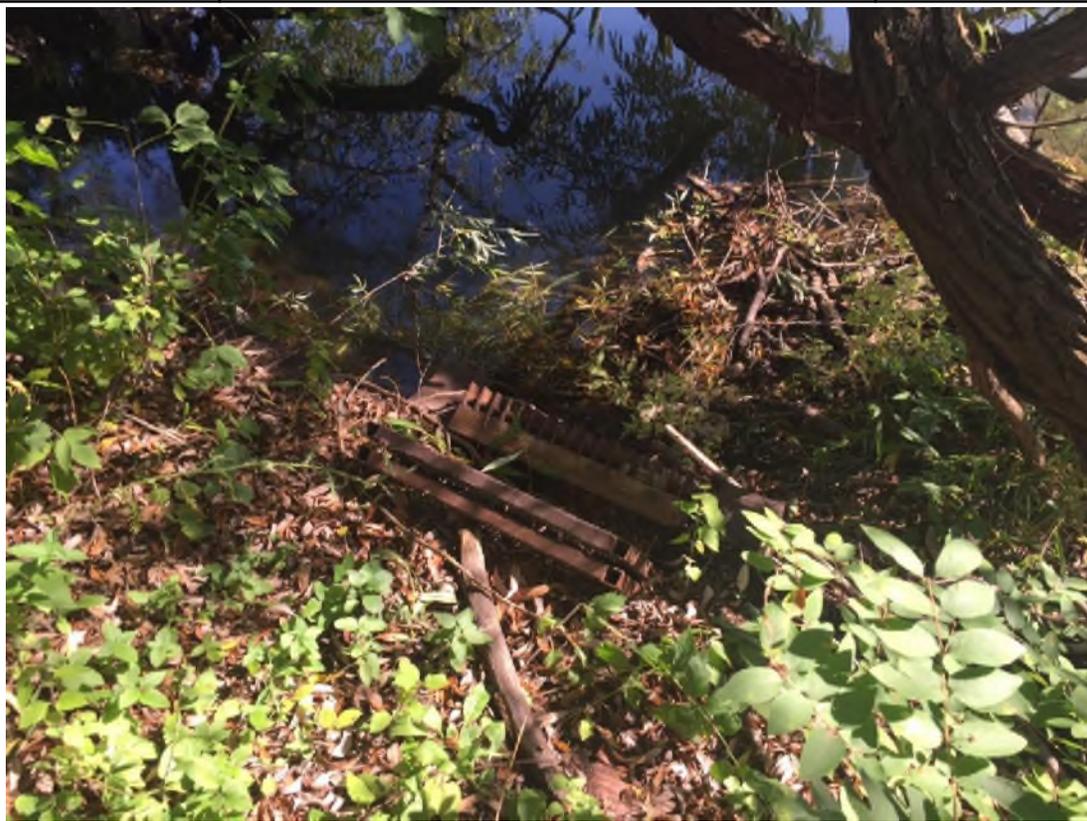
Photograph #20	Vacated Cheese Processing Plant, Fergus Falls, MN	B1606338.01
Date:	September 20, 2017	BRAUN INTERTEC
Direction:	East	
Subject:	Water inlet on river bank to east of south plant

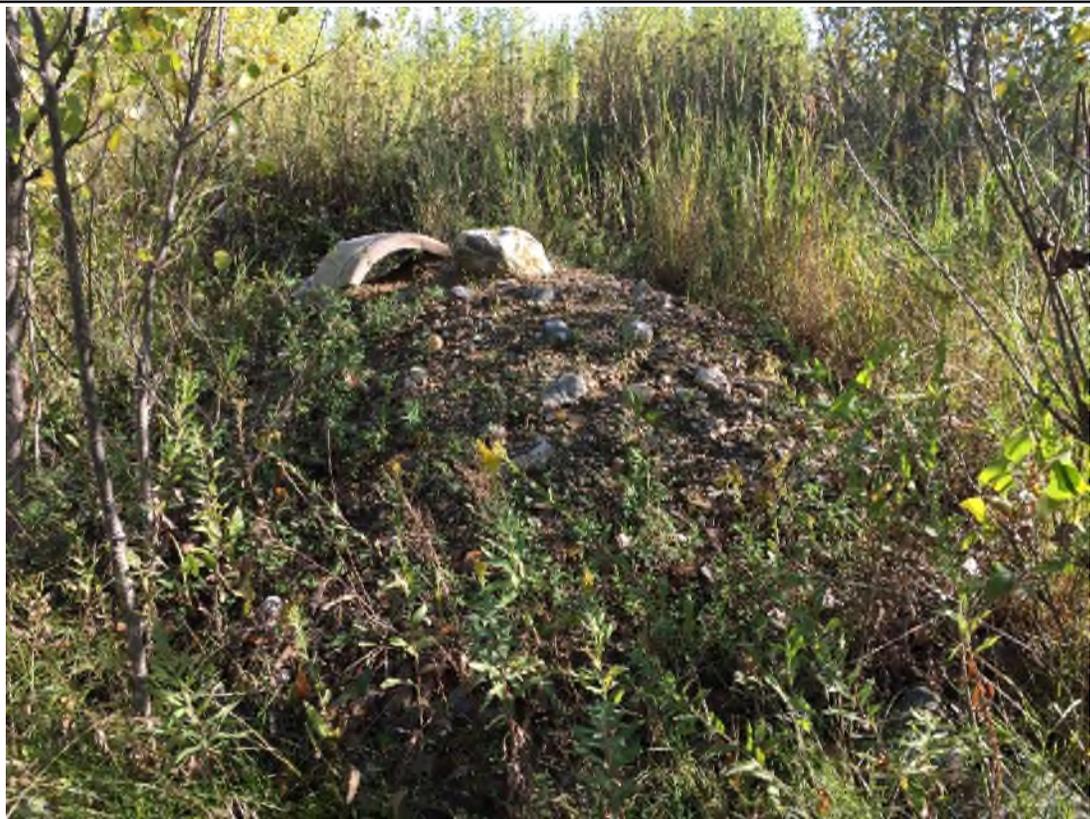
Photograph #23	Vacated Cheese Processing Plant, Fergus Falls, MN	B1606338.01
Date:	September 20, 2017

- The western portion of the Site was formerly a gravel pit. Fill material of unknown nature and origin has been placed on this portion of the Site. This represents a recognized environmental condition.

Direction:	North	
Subject:	Fill/debris pile on western portion of Site

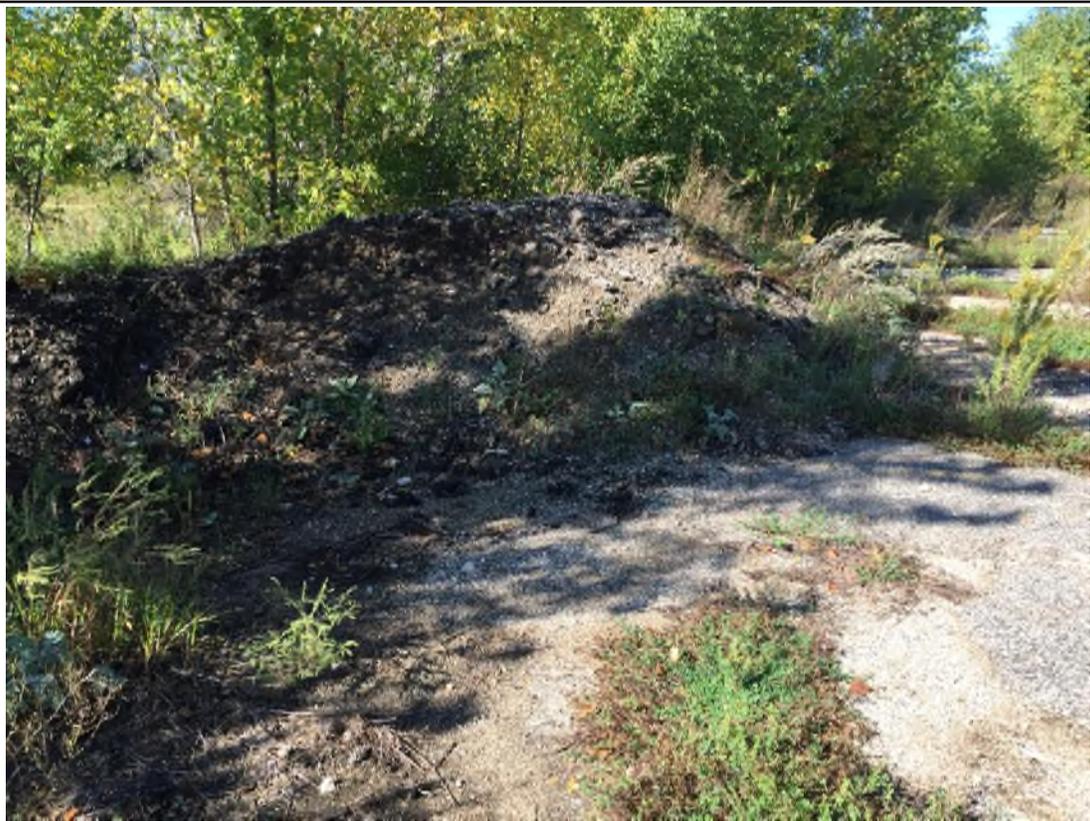
Photograph #25	Vacated Cheese Processing Plant, Fergus Falls, MN	B1606338.01
Date:	September 20, 2017	
Direction:	West	
Subject:	Asphalt debris pile on west end of parking lot

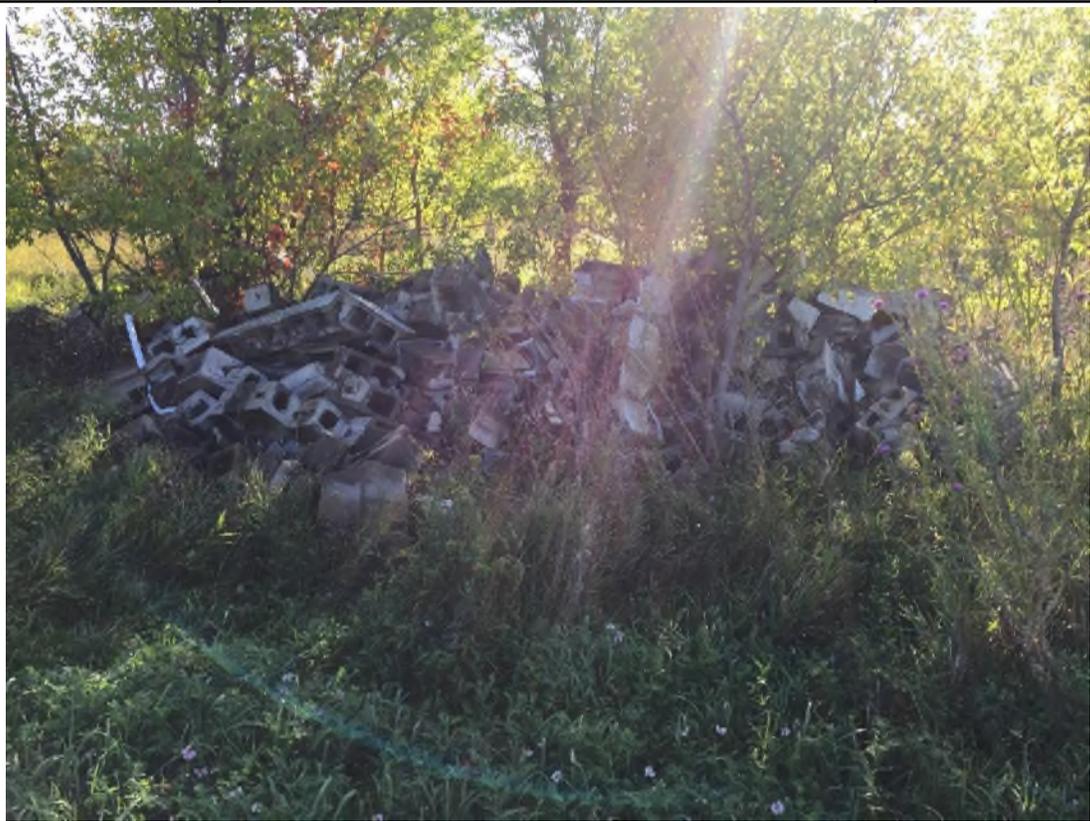
Photograph #26	Vacated Cheese Processing Plant, Fergus Falls, MN	B1606338.01
Date:	September 20, 2017	
Direction:	South	
Subject:	Concrete debris near wastewater treatment plant

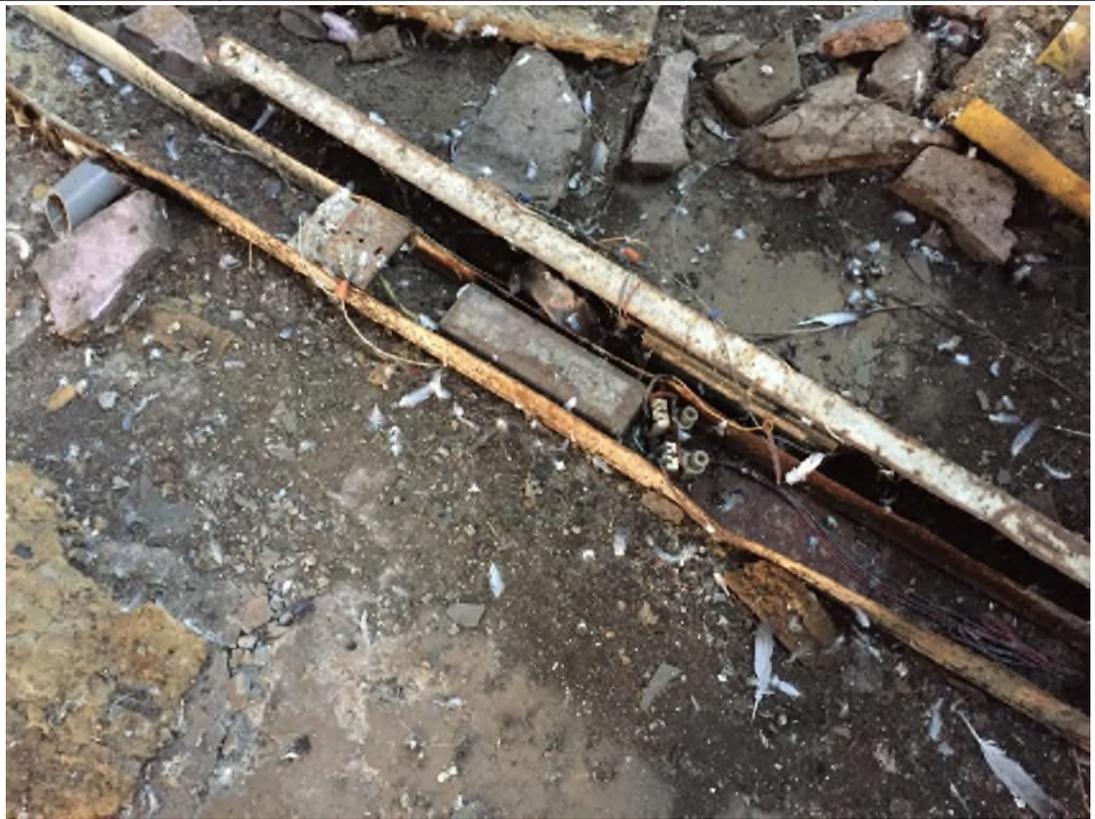
Photograph #28	Vacated Cheese Processing Plant, Fergus Falls, MN	B1606338.01
Date:	September 20, 2017	BRAUN INTERTEC
Direction:	NA	
Subject:	Fluorescent light ballast on floor near boiler room

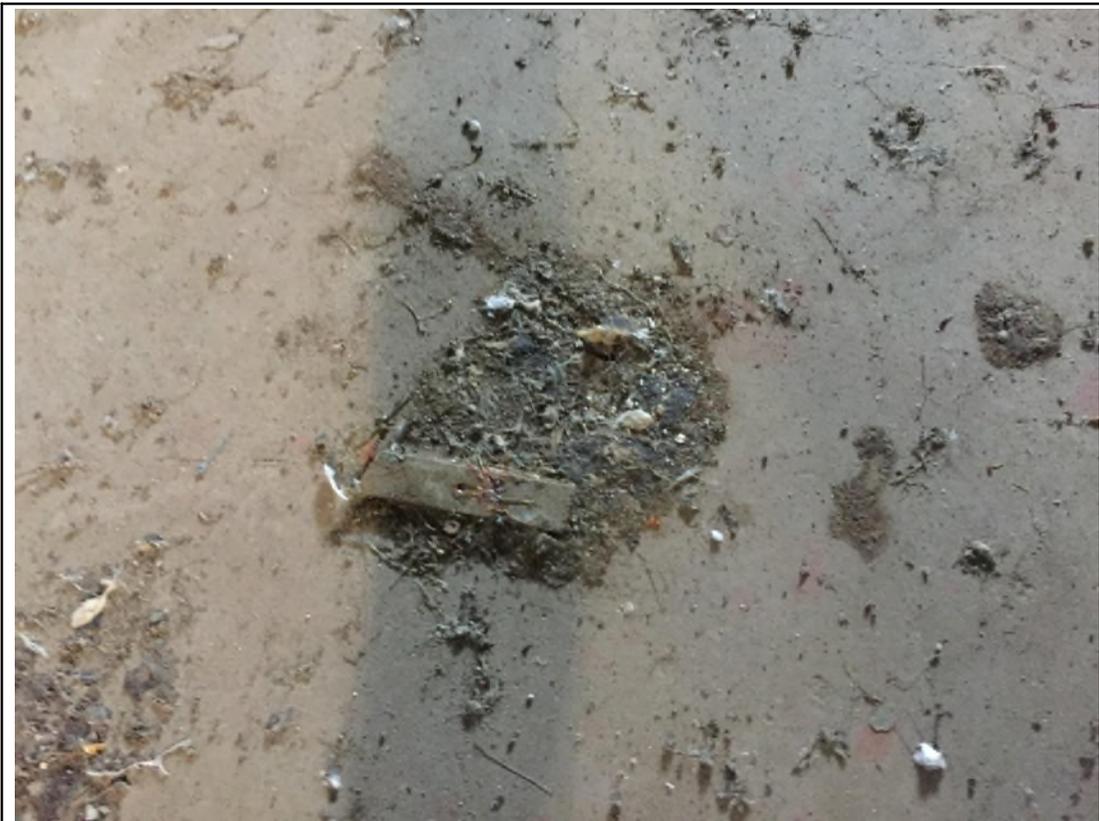
Photograph #29	Vacated Cheese Processing Plant, Fergus Falls, MN	B1606338.01
Date:	September 20, 2017

Damaged friable asbestos and an elemental mercury release is located within the boiler room of the north plant building.

Direction:	NA	
Subject:	Free mercury on floor of boiler room in north plant

The damaged friable asbestos and elemental mercury release located within the boiler room in the north plant building represents a possible material risk to human health and environment. Braun Intertec recommends this matter be cleaned-up/addressed to proper regulatory agency satisfaction without delay.

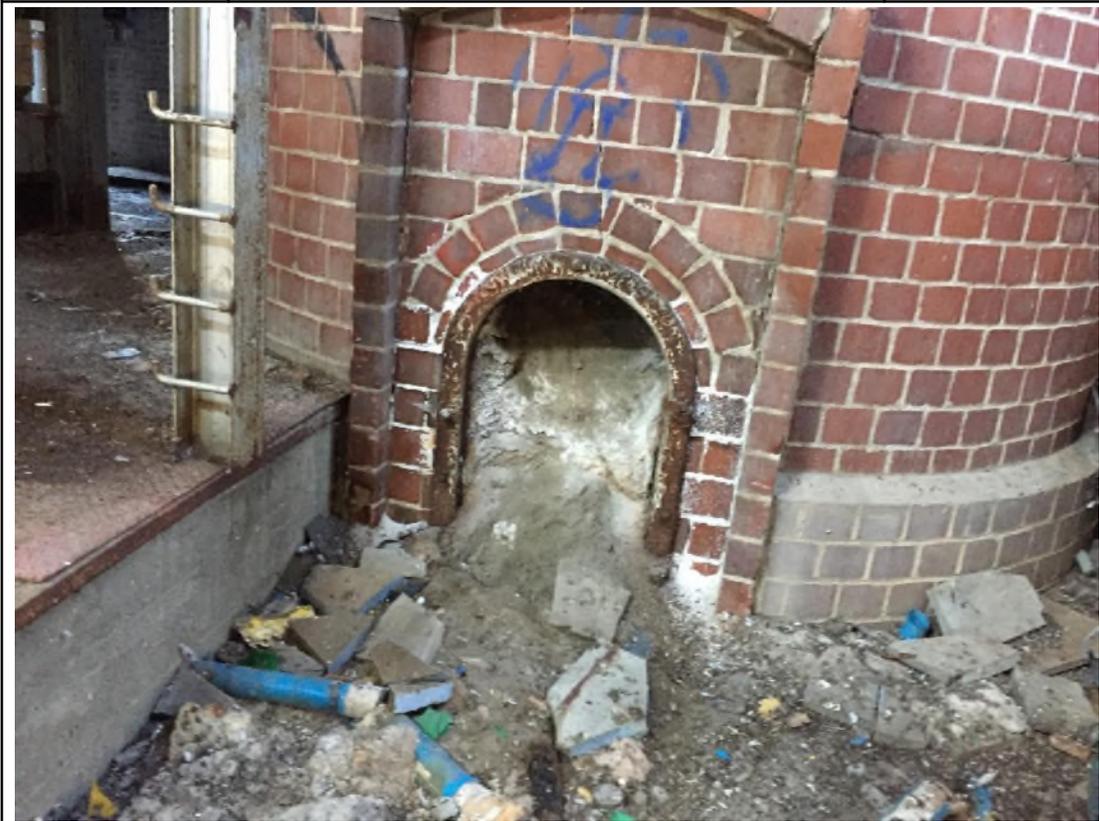
Photograph #30	Vacated Cheese Processing Plant, Fergus Falls, MN	B1606338.01
Date:	September 20, 2017

Direction:	North	
Subject:	Ash in stack in boiler room of north plant

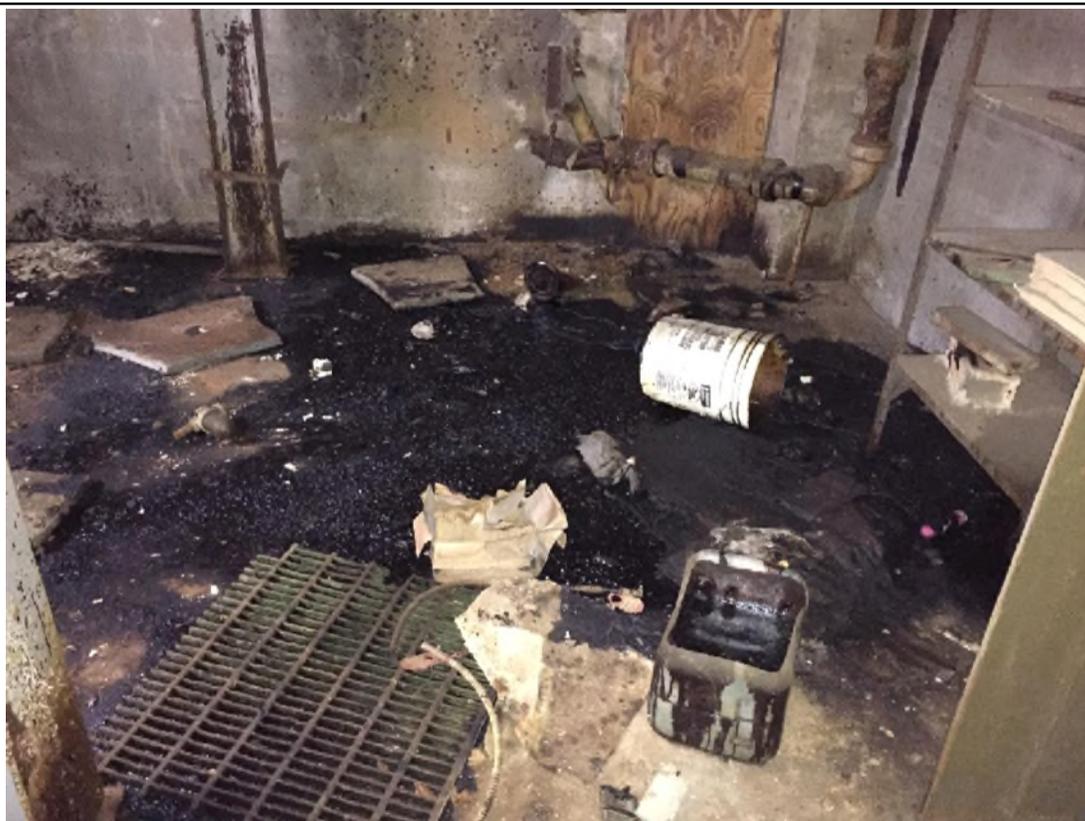
Photograph #31	Vacated Cheese Processing Plant, Fergus Falls, MN	B1606338.01
Date:	September 20, 2017	BRAUN INTERTEC
Direction:	East	
Subject:	Oil staining on basement floor of boiler room

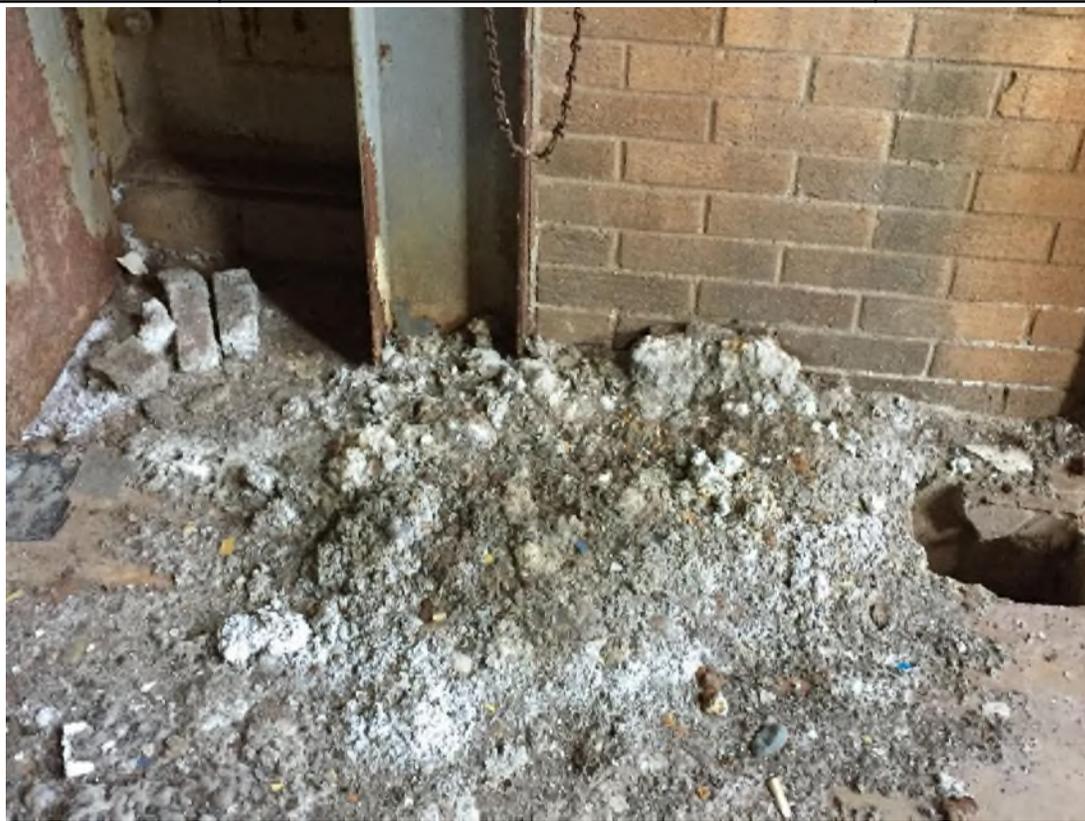
Photograph #32	Vacated Cheese Processing Plant, Fergus Falls, MN	B1606338.01
Date:	September 20, 2017	BRAUN INTERTEC
Direction:	North	
Subject:	ACM debris in boiler room in north plant building

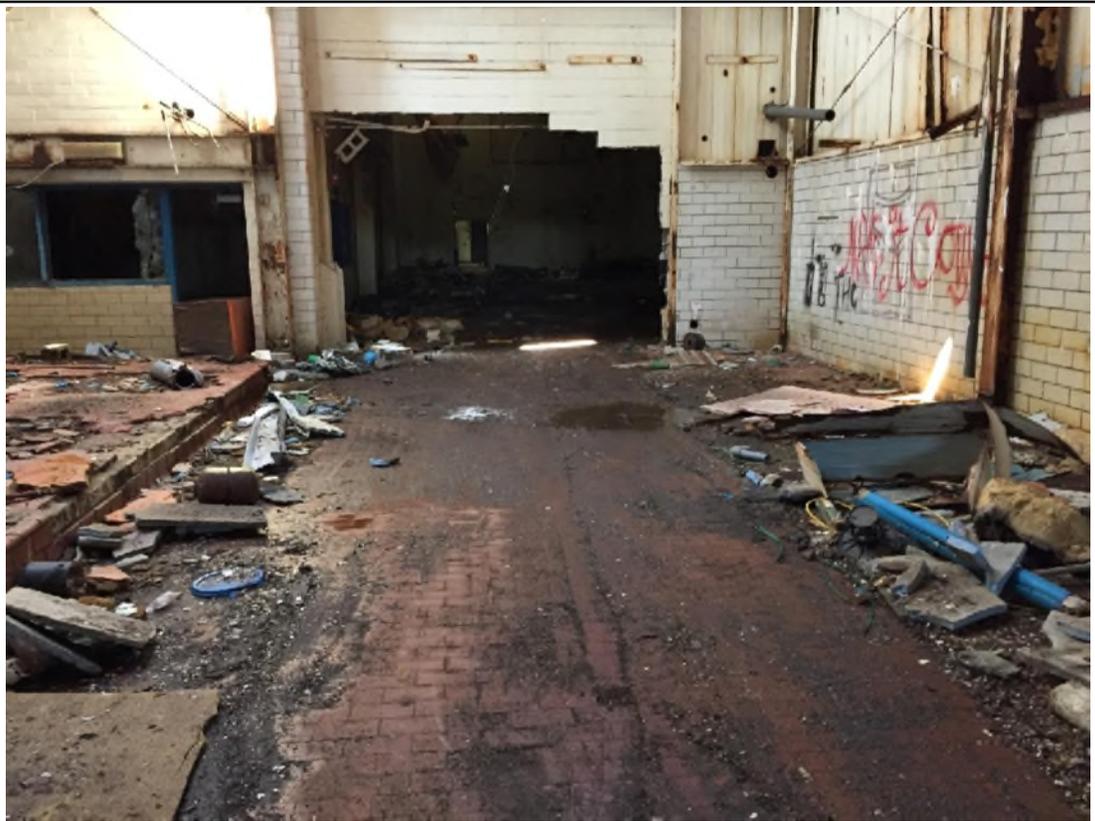
Photograph #33	Vacated Cheese Processing Plant, Fergus Falls, MN	B1606338.01
Date:	September 20, 2017	BRAUN INTERTEC
Direction:	West	
Subject:	Interior of north plant building

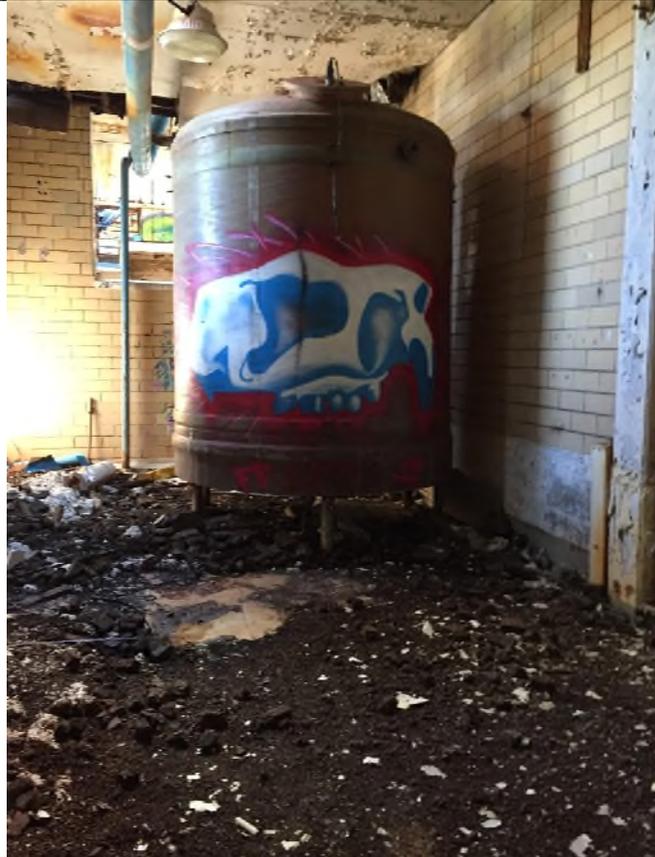
Photograph #34	Vacated Cheese Processing Plant, Fergus Falls, MN	B1606338.01
Date:	September 20, 2017	BRAUN INTERTEC
Direction:	NA	
Subject:	AST in mezzanine of north plant building

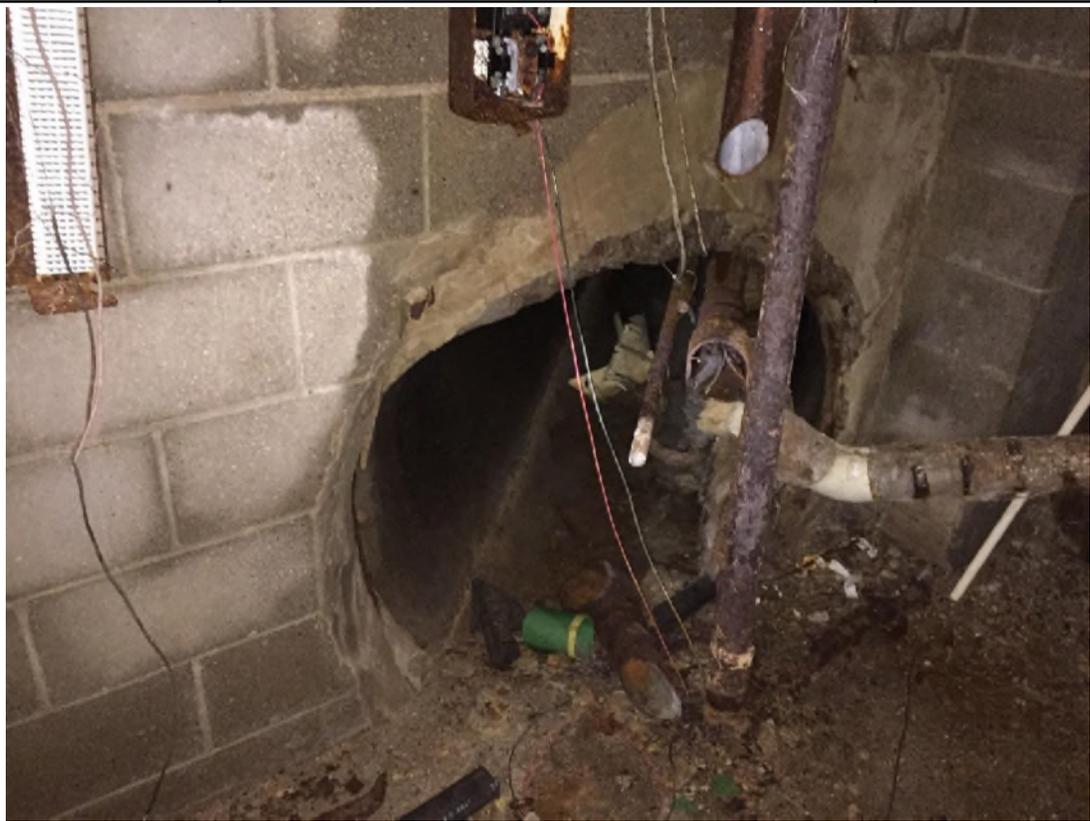
Photograph #36	Vacated Cheese Processing Plant, Fergus Falls, MN	B1606338.01
Date:	September 20, 2017	BRAUN INTERTEC
Direction:	South	
Subject:	Tunnel in basement of south plant building

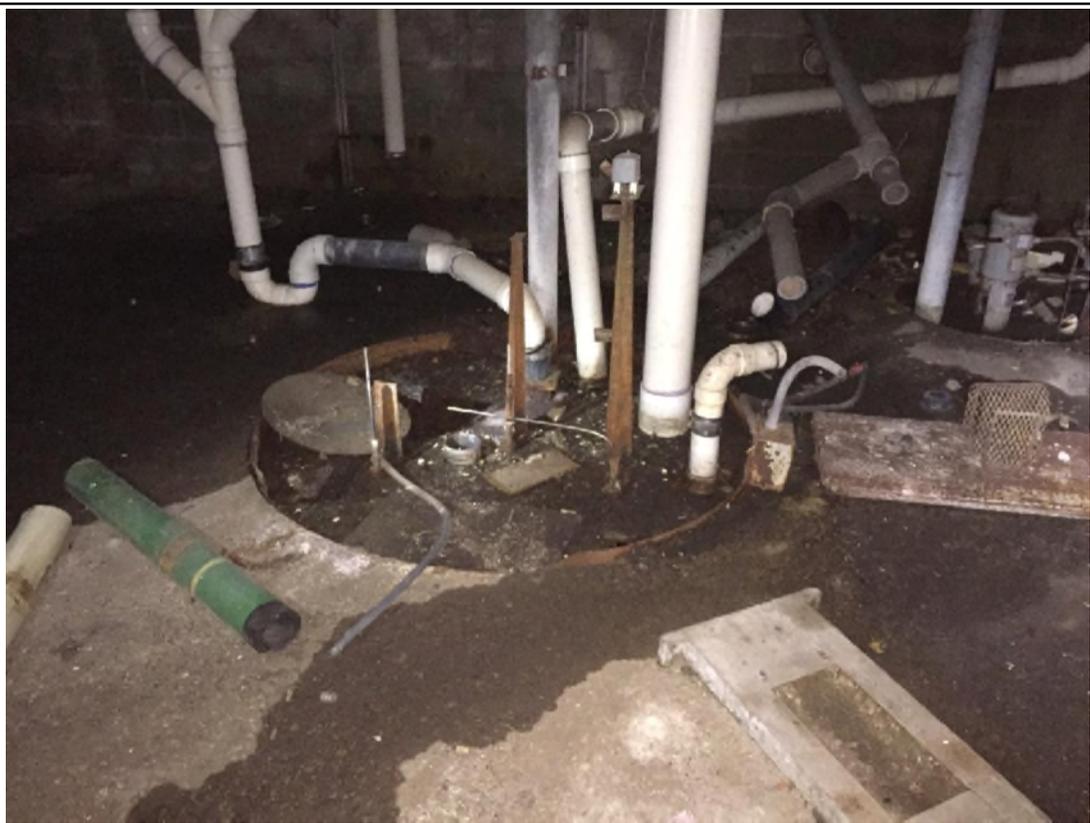
Photograph #37	Vacated Cheese Processing Plant, Fergus Falls, MN	B1606338.01
Date:	September 20, 2017	BRAUN INTERTEC
Direction:	North	
Subject:	Sump pump in basement of south plant building

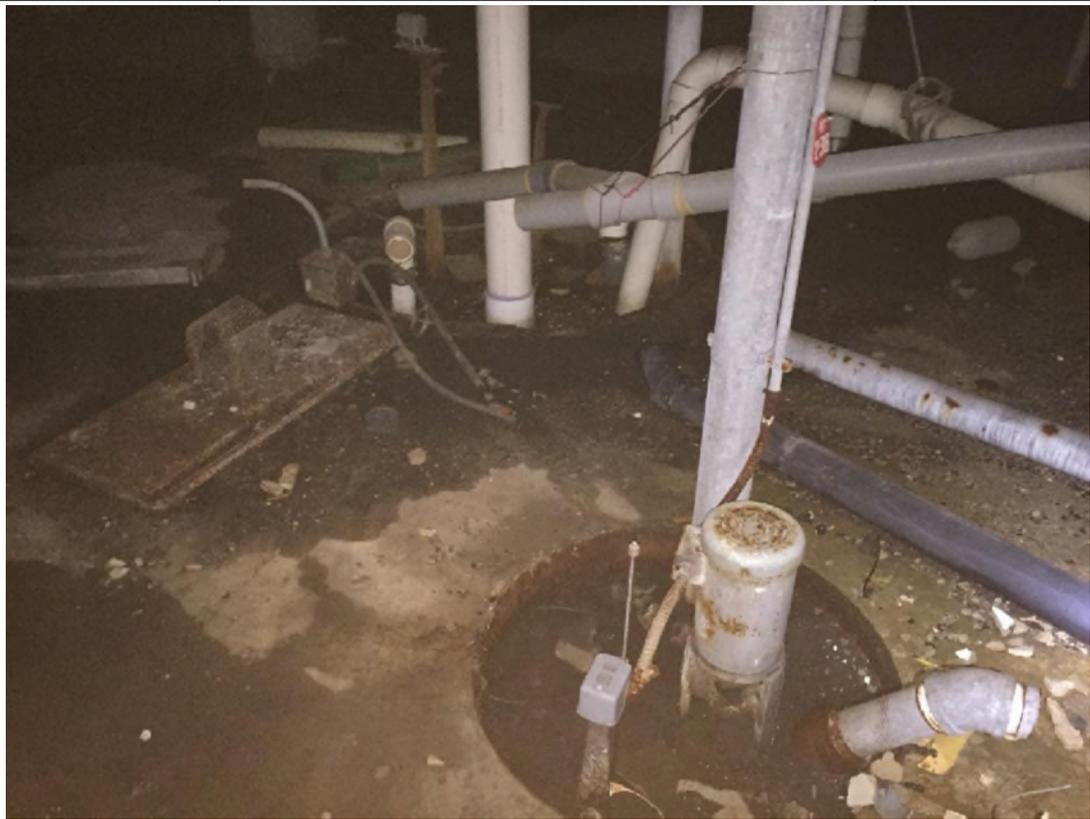
Photograph #38	Vacated Cheese Processing Plant, Fergus Falls, MN	B1606338.01
Date:	September 20, 2017	BRAUN INTERTEC
Direction:	North	
Subject:	Sump pump in basement of south plant building

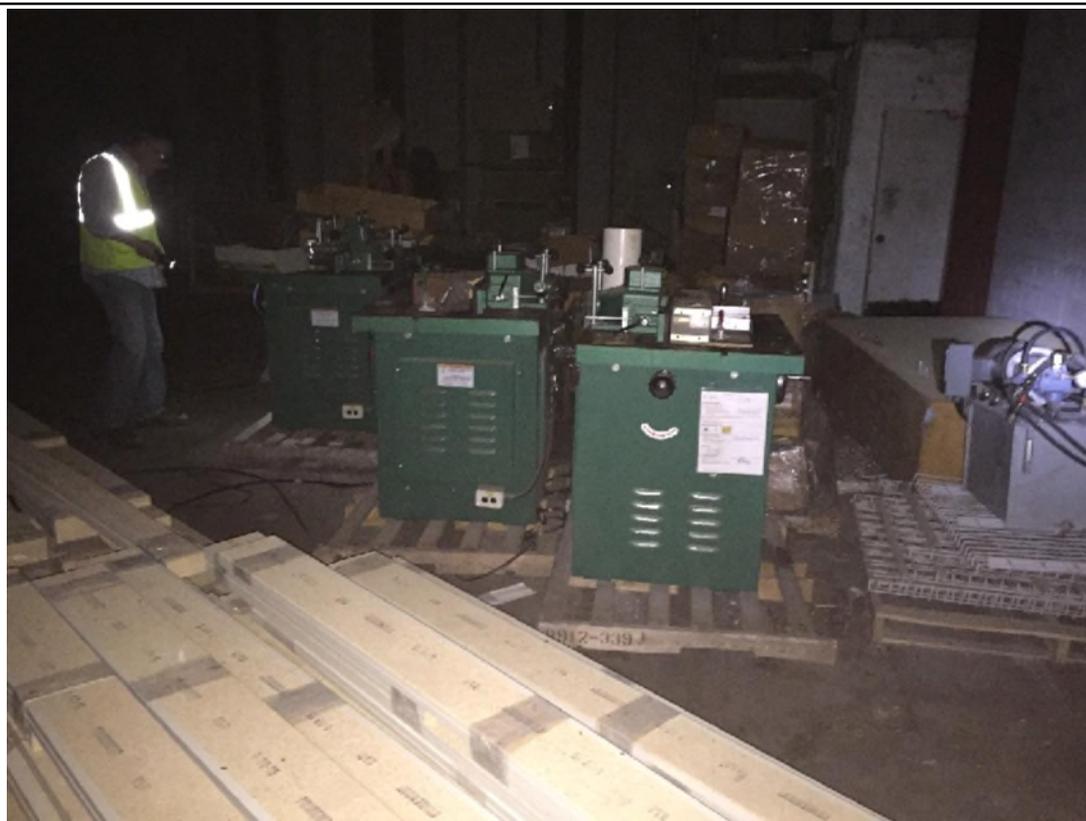
Photograph #39	Vacated Cheese Processing Plant, Fergus Falls, MN	B1606338.01
Date:	September 20, 2017	BRAUN INTERTEC
Direction:	South	
Subject:	Window company storage in south plant building

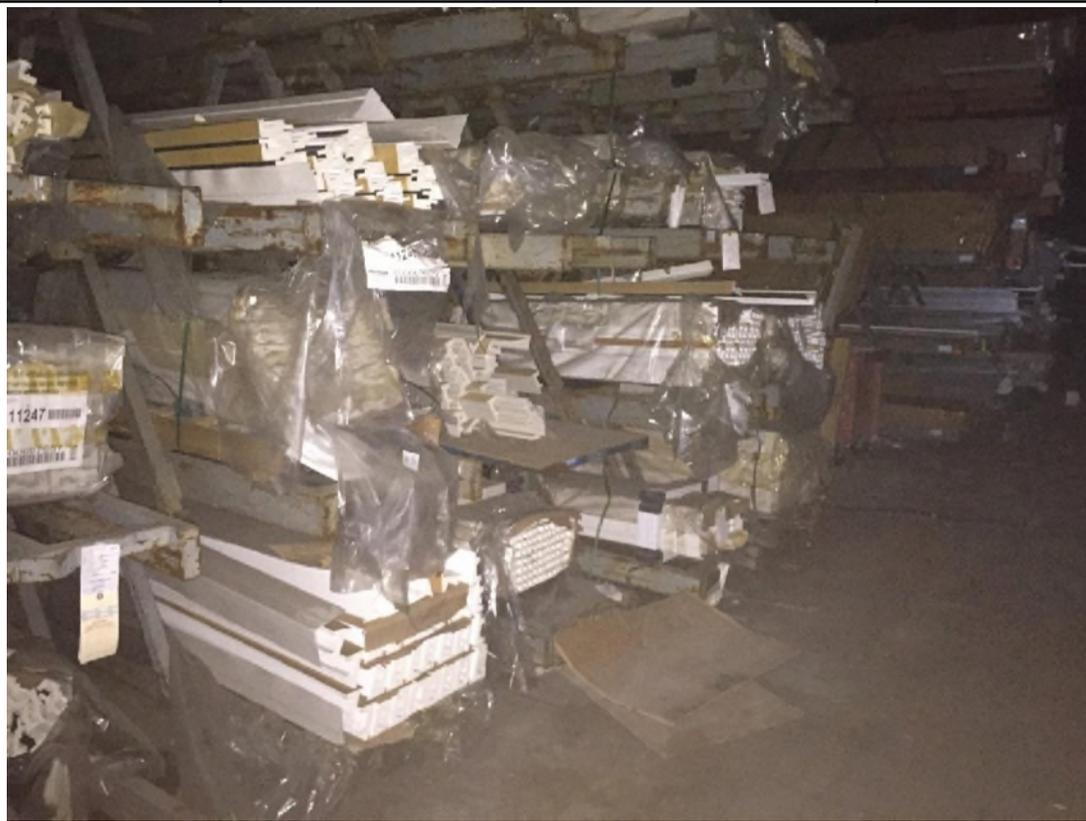
Photograph #40	Vacated Cheese Processing Plant, Fergus Falls, MN	B1606338.01
Date:	September 20, 2017	BRAUN INTERTEC
Direction:	South	
Subject:	Window company storage in south plant building
